REPORT OF MEETING

SUBJECT: Lyman Viaduct – Culvert Rehabilitation Project
Town of Colchester

DATE: May 1, 2008

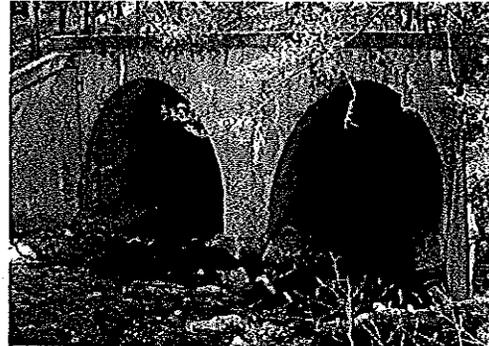
Inlet Headwall and Wingwalls

The entire concrete surface was hammer tapped to determine areas of deteriorated concrete. There are only minor areas of unsound concrete with the majority of the deterioration located near concrete construction joints at/or the near the waterline. All deterioration noted was delineated with survey marking paint to quantify future repair areas. There is no evidence of scouring in the stream channel at the inlet of the structure. There are no serious deficiencies at the culvert inlet that need immediate repair.

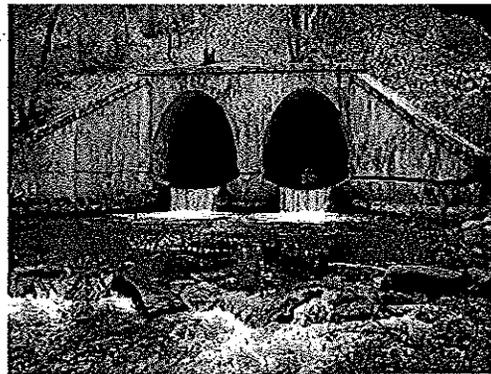
Outlet Pool Scour (Erosion)

The entire outlet of the structure and its adjacent wingwalls are undermined both vertically and horizontally. The vertical measurements shown on the enclosed sketches represent vertical scour dimensions from the bottom of the footing to the bottom of the stream channel. The vertical measurements vary from approximately 2 to 7 feet. The horizontal measurements represent the horizontal scour dimension measured from face of the wall to existing grade. At certain locations the dimensions cited are approximate due to accessibility but the measurements vary from 2 feet to 12 feet. Note that in the photo at right the bottom of footings is located above the waterline.

These dimensions indicate that the entire outlet structure is experiencing major erosion and scour. All footing toes are exposed and the undercutting is excessive in many locations.

The eastern outlet retaining wall (right side of photo above) is currently in a failed state. The lower portion of the wall below the horizontal construction joint has settled and rotated approximately 3½ inches. The upper portion of the wall has moved laterally approximately 8 inches.

1. Underpin the existing headwall and wingwall footings to stabilize the structures. This will be done by placing cast-in-place concrete under the footings down to the bottom of the existing scour holes.
2. Fill the scour hole up to an elevation of approximately 3 feet below the proposed stream channel grade (approximately 14 feet at the deepest). The fill will either be large diameter stone or a combination of stone and flowable fill. Flowable fill is a mixture of sand water and a small amount of cement. When installed, it has the consistency of hard sand. The intent of the filling operation is not to use compacted gravel or soil.

3. In order to prevent a future scour hole, a reinforced concrete apron slab is proposed under the stream channel. This slab will span the entire width of the outlet pool and be tied into the existing headwall and wingwall footings. The approximate dimensions of this slab are 60' by 60'. This slab will not be visible in the completed structure.
4. Large diameter stones will be placed on top of the concrete slab and anchored to it. It is the intent to have these stones protruding from the water surface during normal flows. The large stones will assist with the dissipation of energy as the water exits the culvert.
5. Smaller diameter stones will then be placed between the large stones to create a natural stream channel.
6. Once the outlet pool is filled, a chain link fence will be install on top of the headwall and wingwalls to prevent swimmers from attempting to jump into the creek.

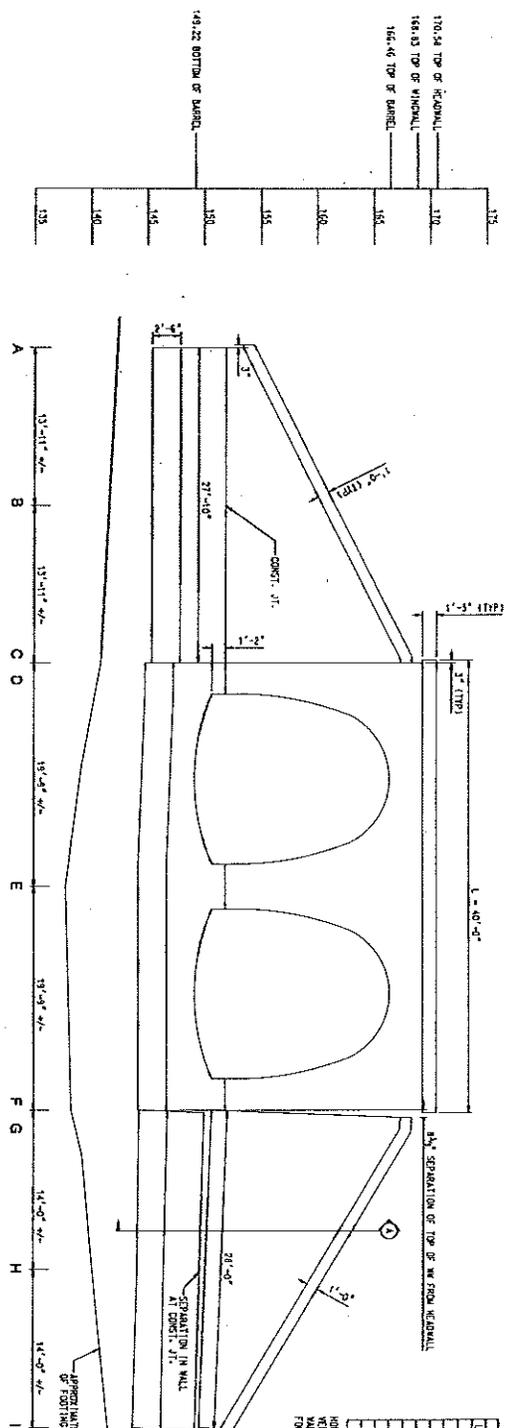
OUTLET (SOUTH) EAGE
SCALE: 1/8"

VERTICAL - UNDERMINING MEASURED FROM FACE OF FOOTING
VERTICAL - TOP OF BOTTOM OF FOOTING TO GRADE
VERTICAL - TOP OF FOOTING TO GRADE
ROTATION - ROTATION MEASURED FROM TOP OF FOOTING TO CONCT. JOINT

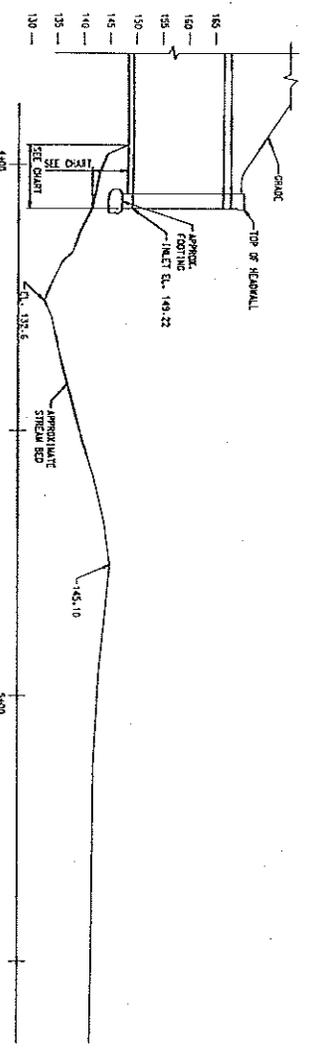
PROFILE - EAST BARREL
SCALE: 1/4"

At its deepest point the bottom of the outlet pool is approximately 17 feet below the flow line of the culvert. See the enclosed profile.
