RE: Structural Engineering Consultation Services
Hillside Place Condominium, New Britain, CT

Scope of Work

HILLSIDE PLACE CONDOMINIUMS
 27 HILLSIDE PLACE
 NEW BRITAIN, CONNECTICUT

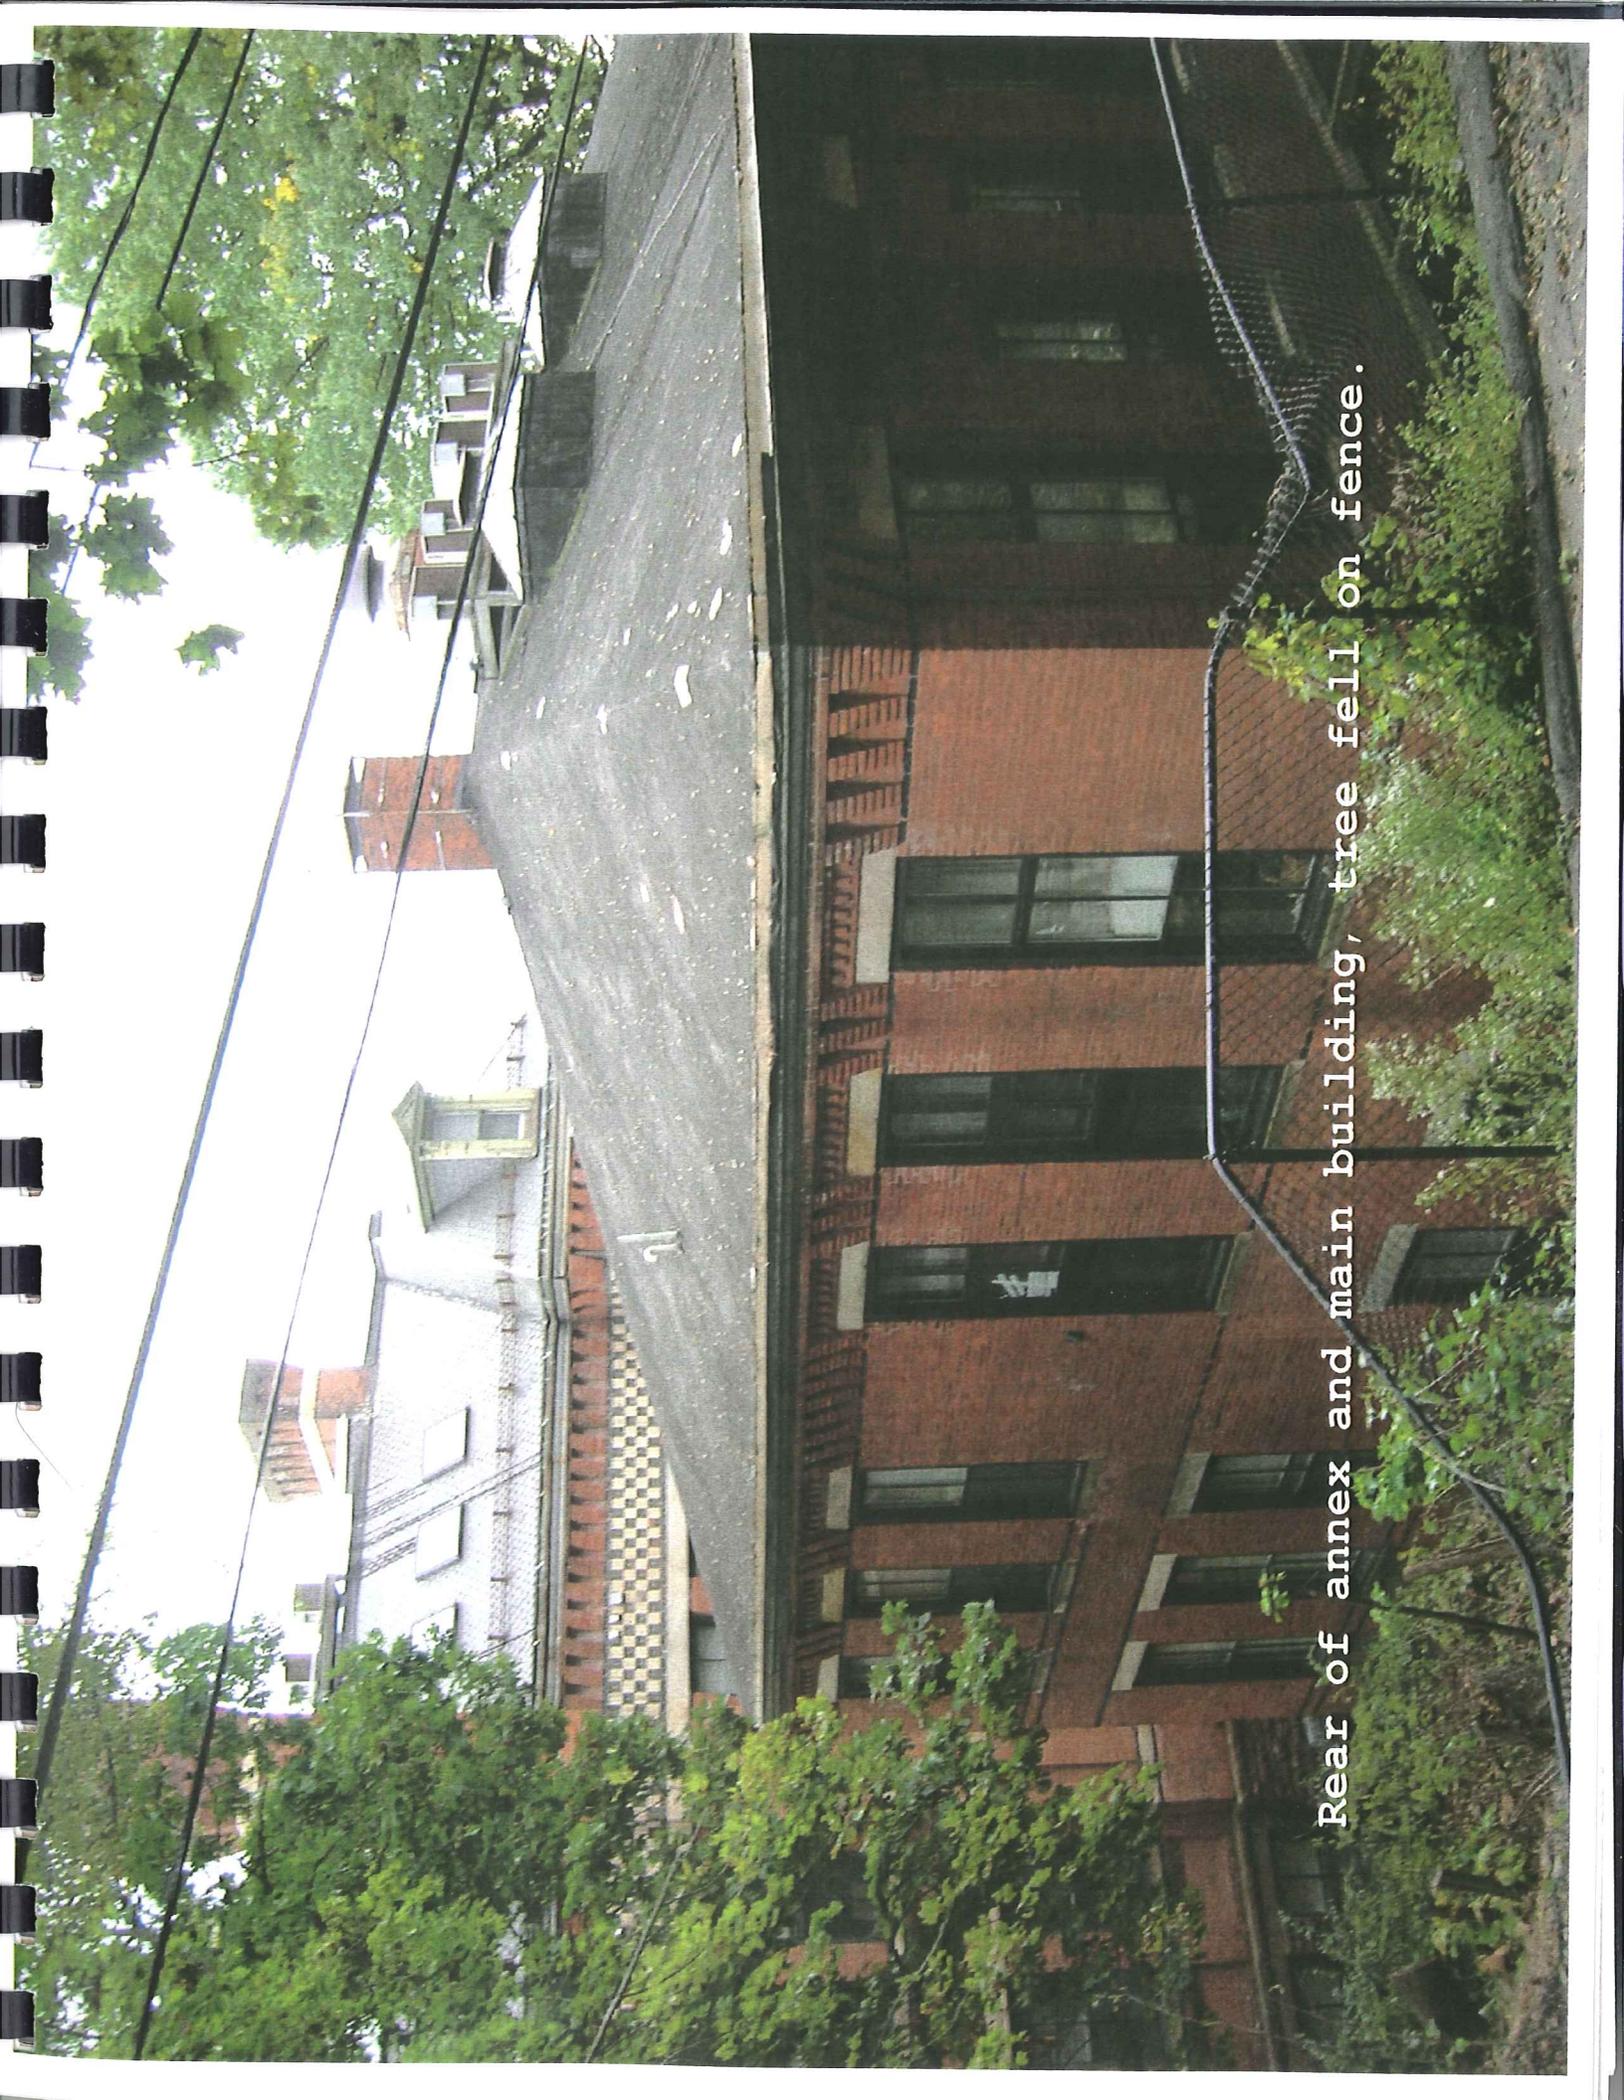
Rear of annex and main building, tree fell on fence.

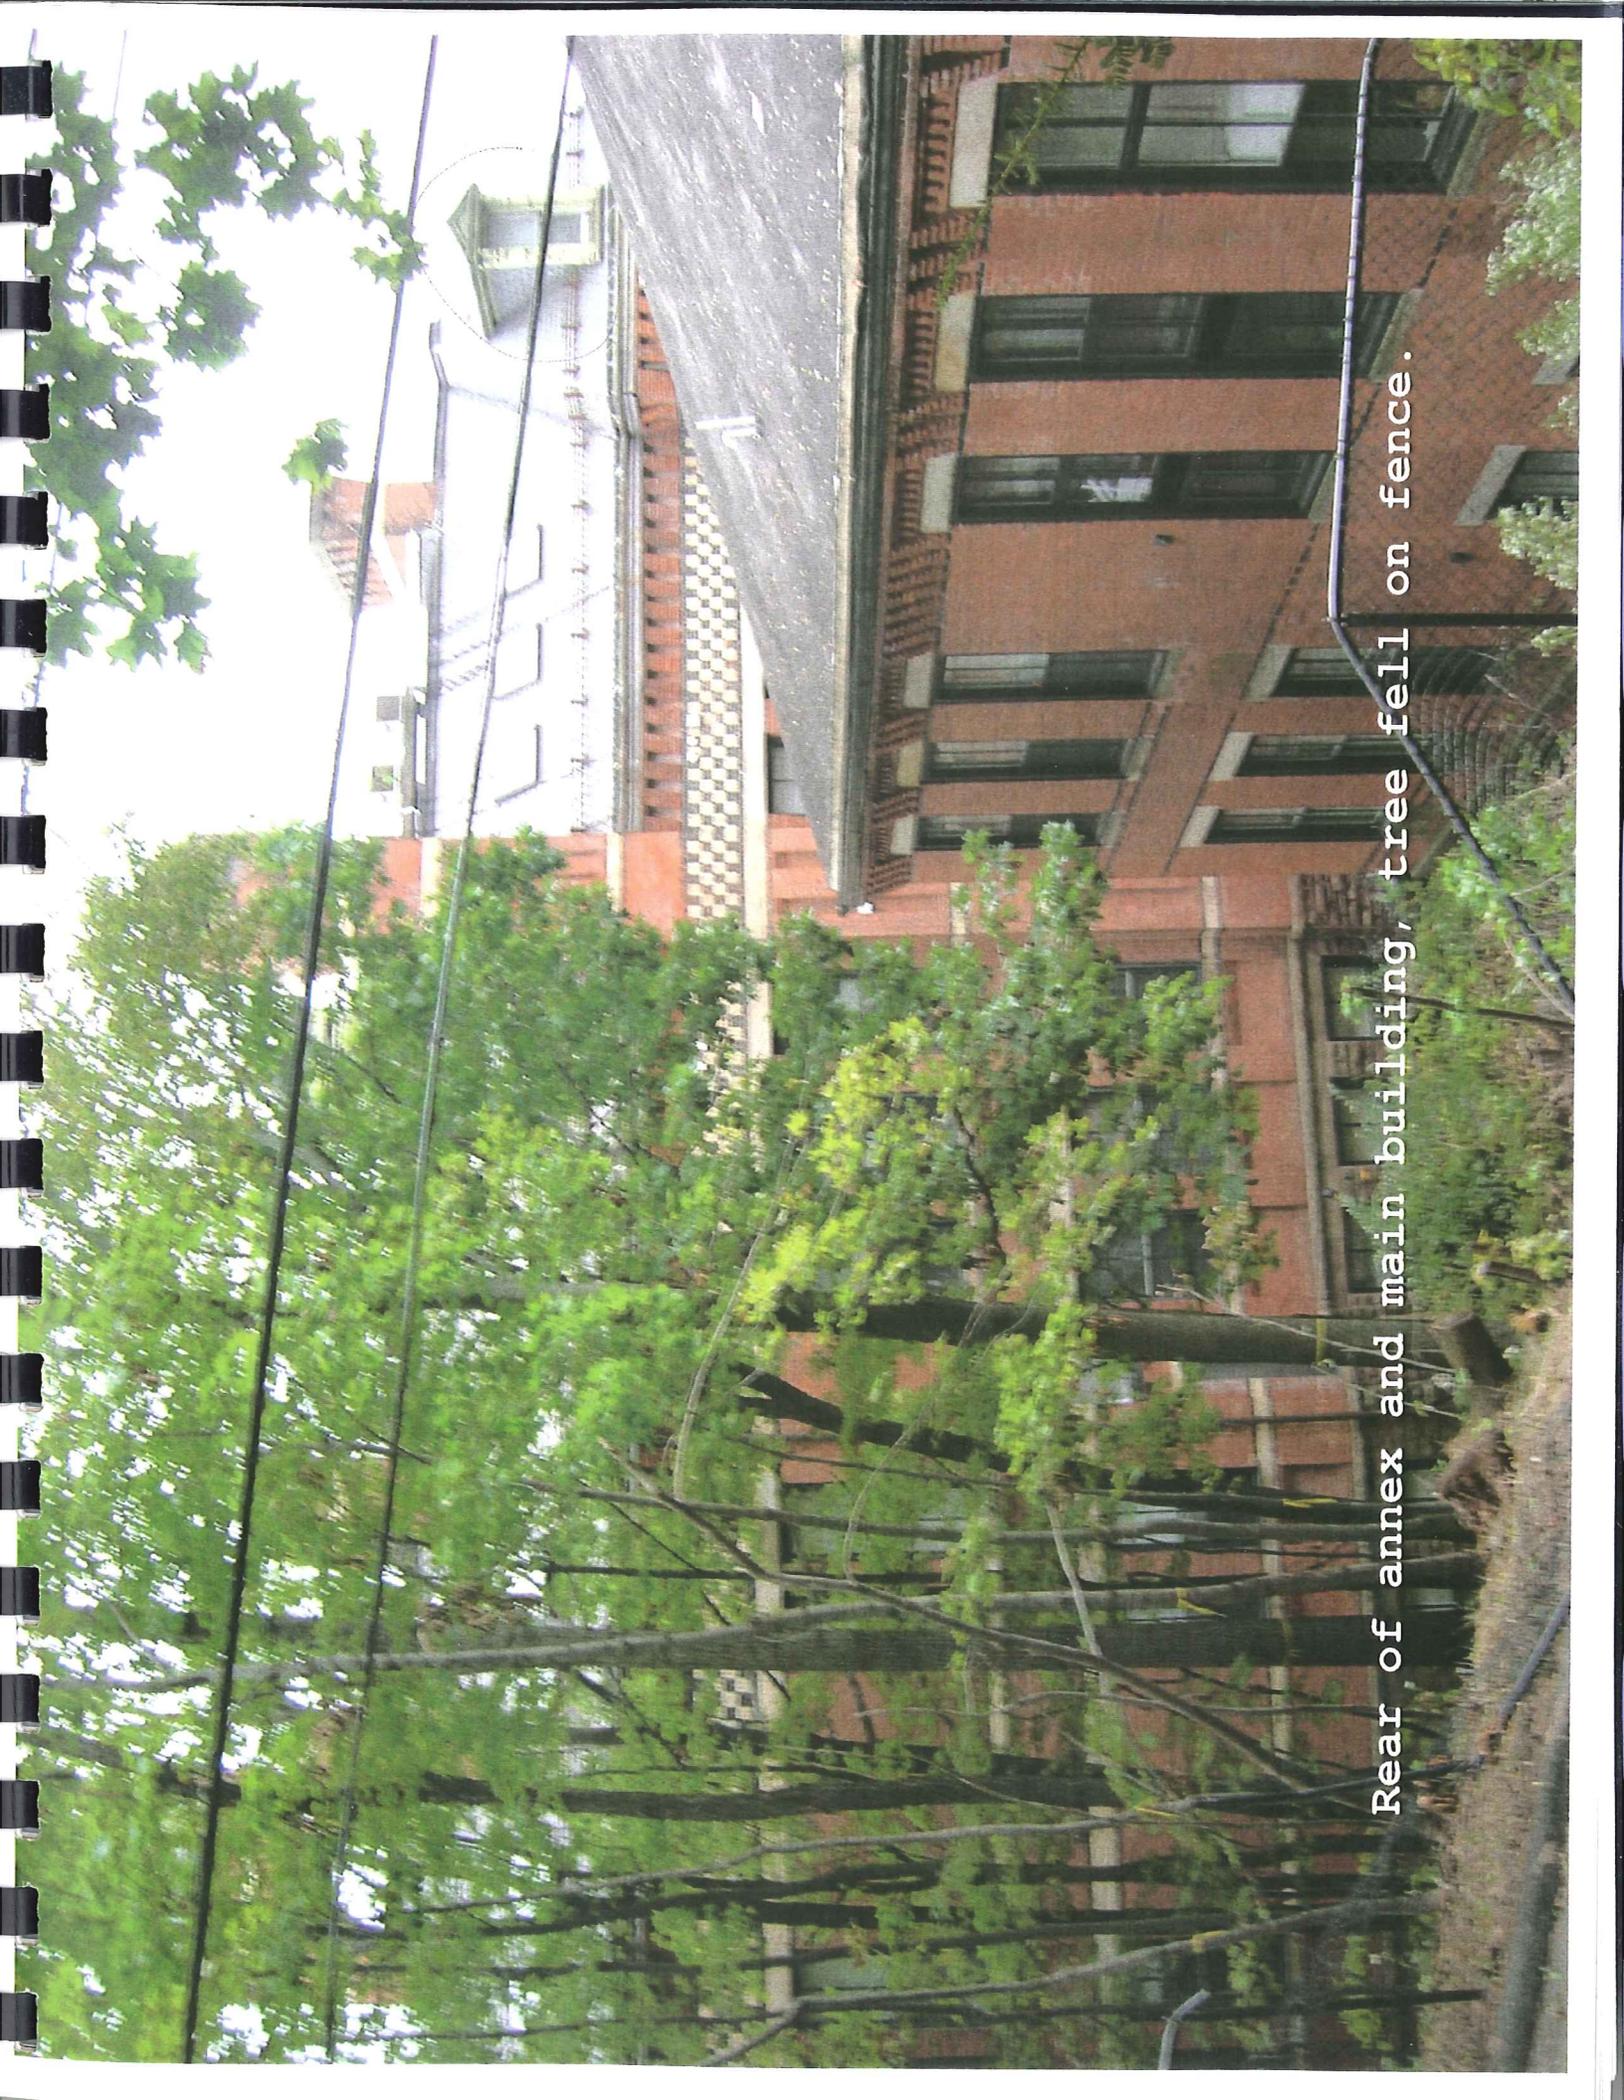
Rear of annex and main building, tree fell on fence.

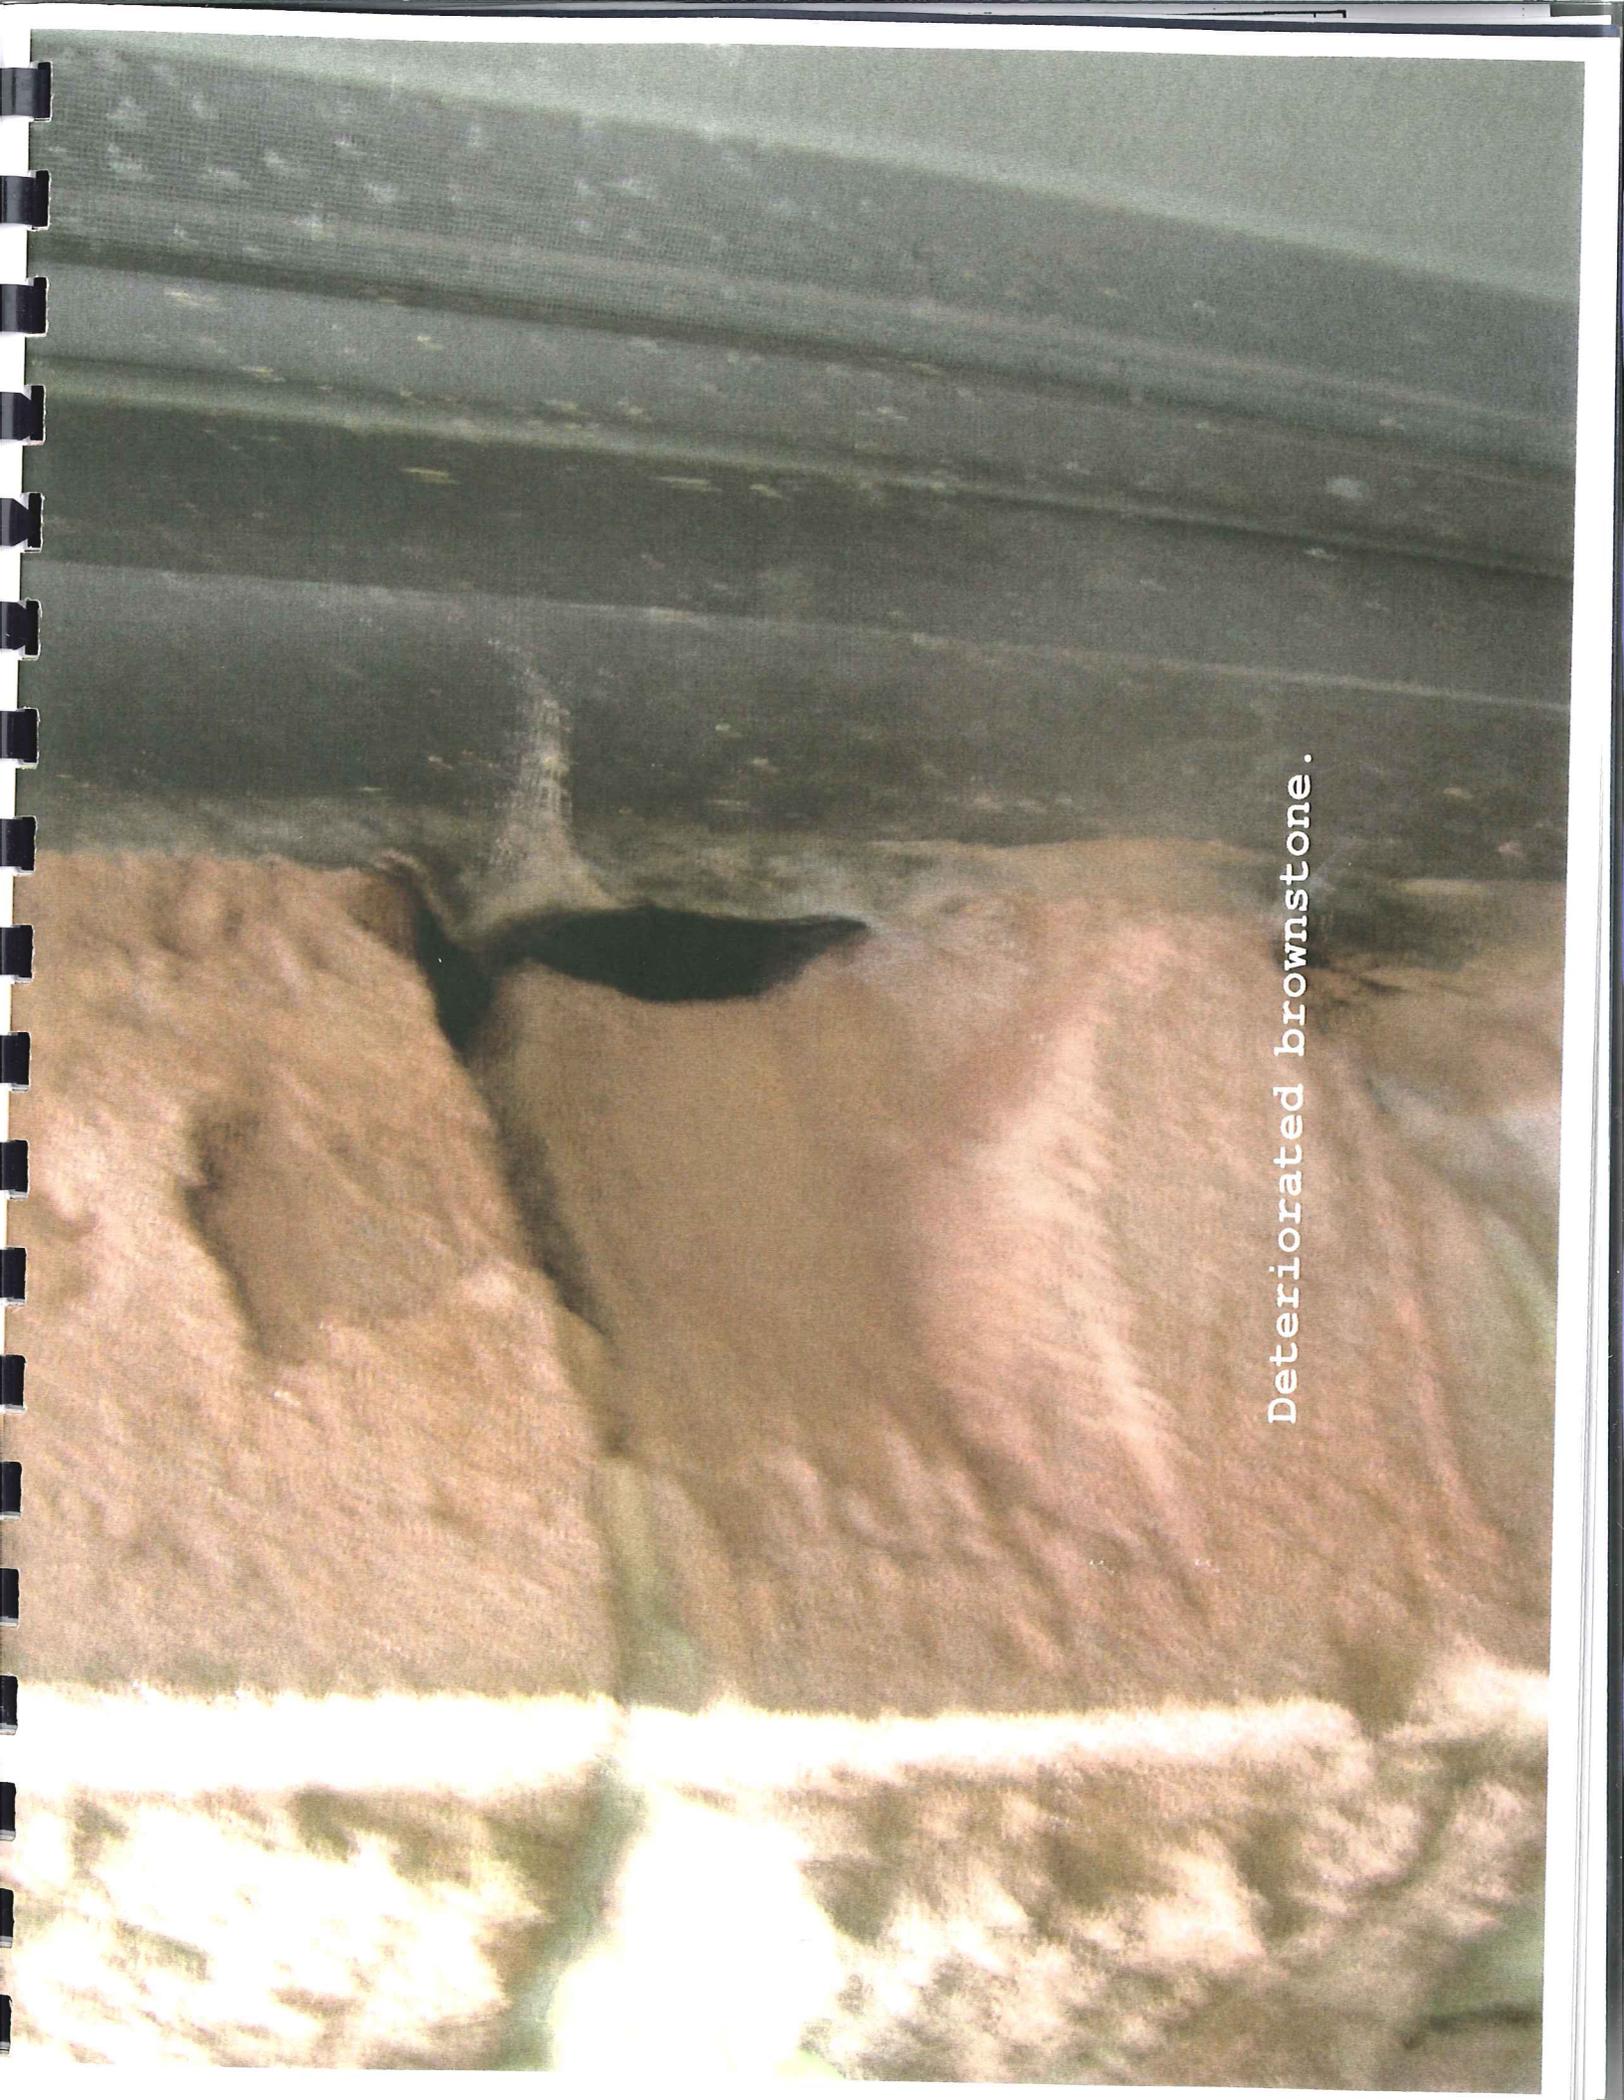
Deteriorated brownstone.

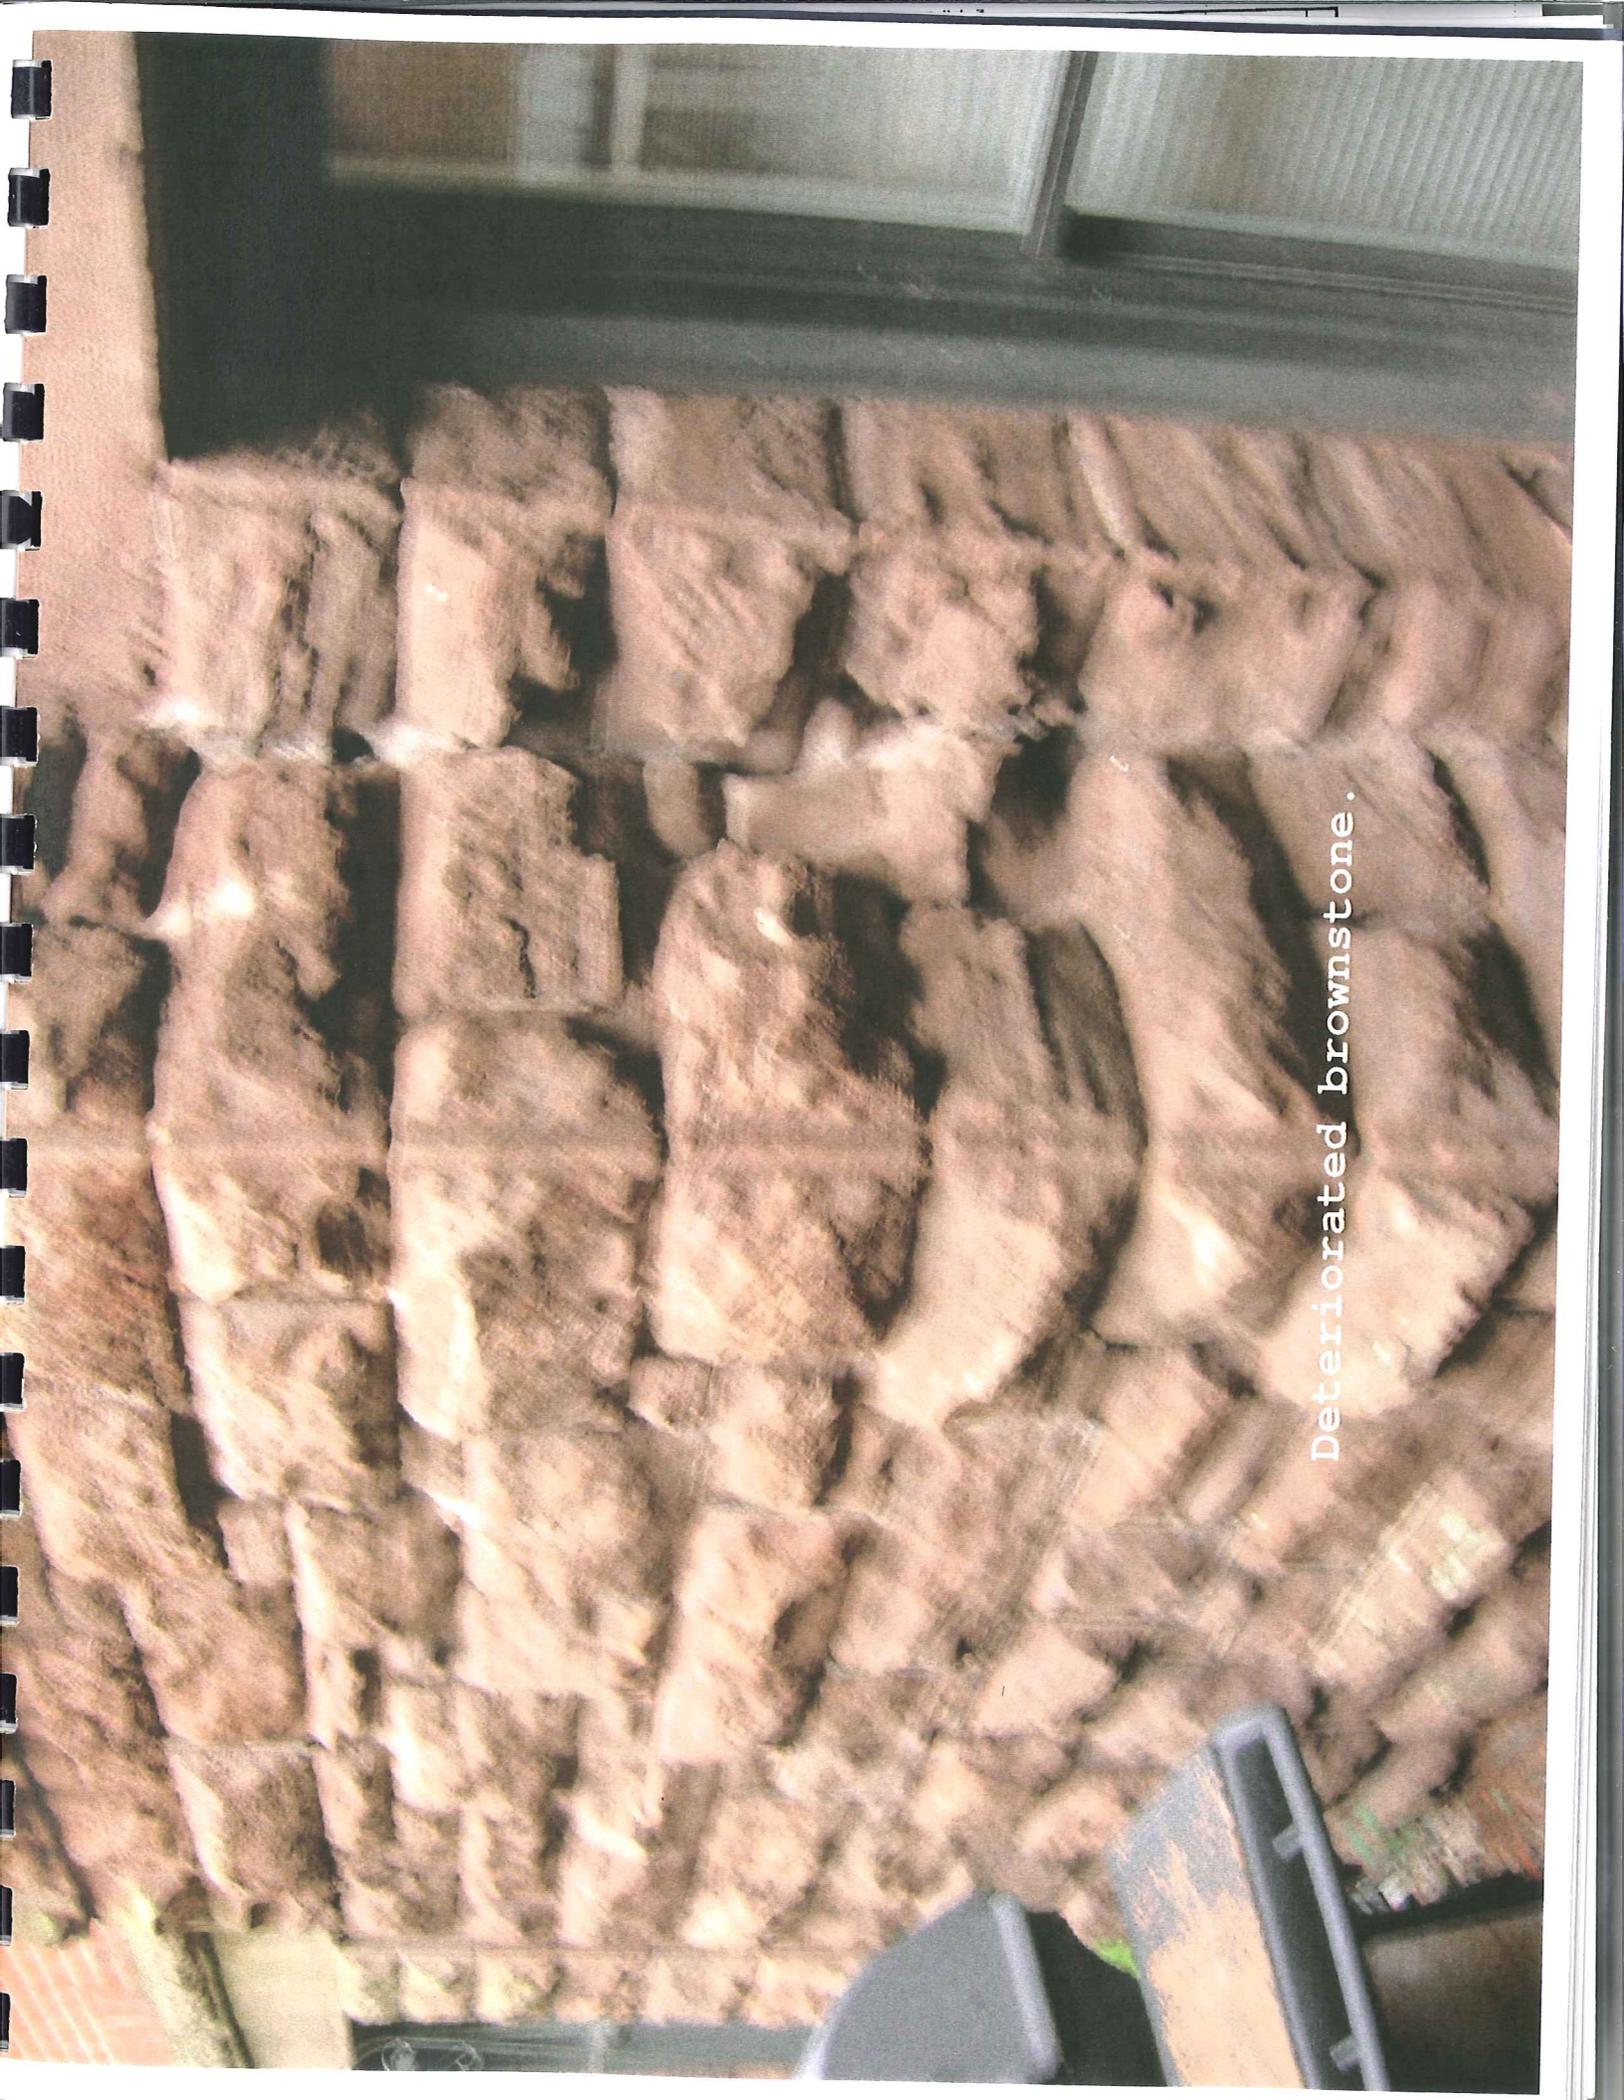
Deteriorated brownstone.

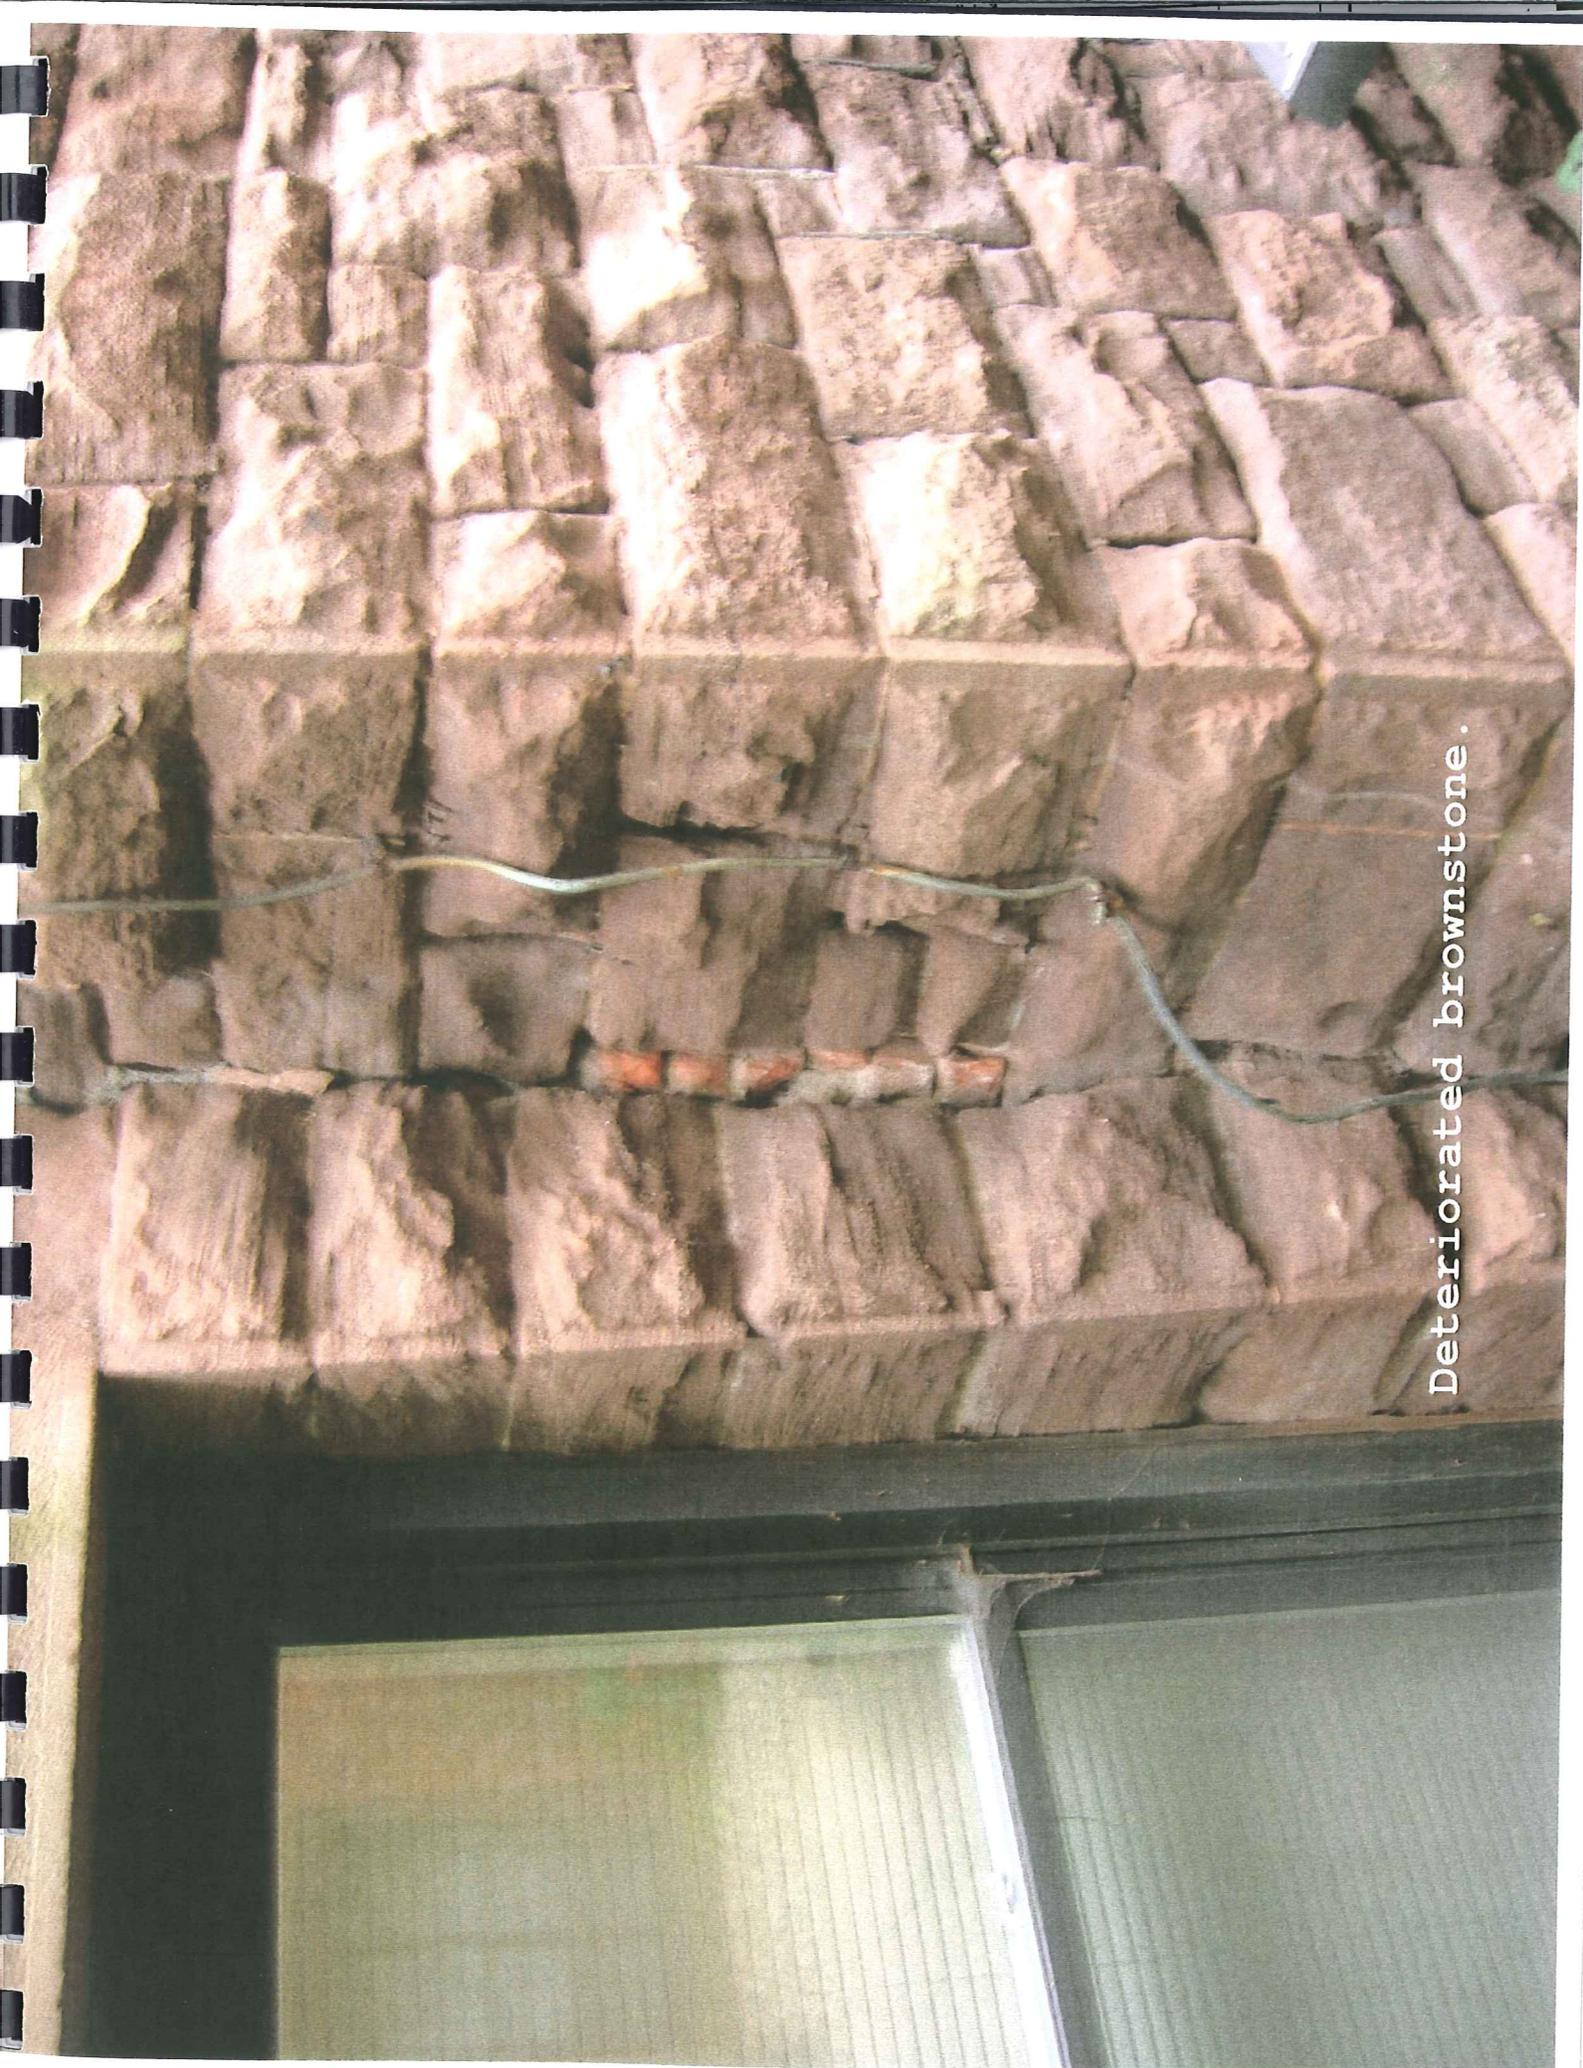
Deteriorated brownstone.

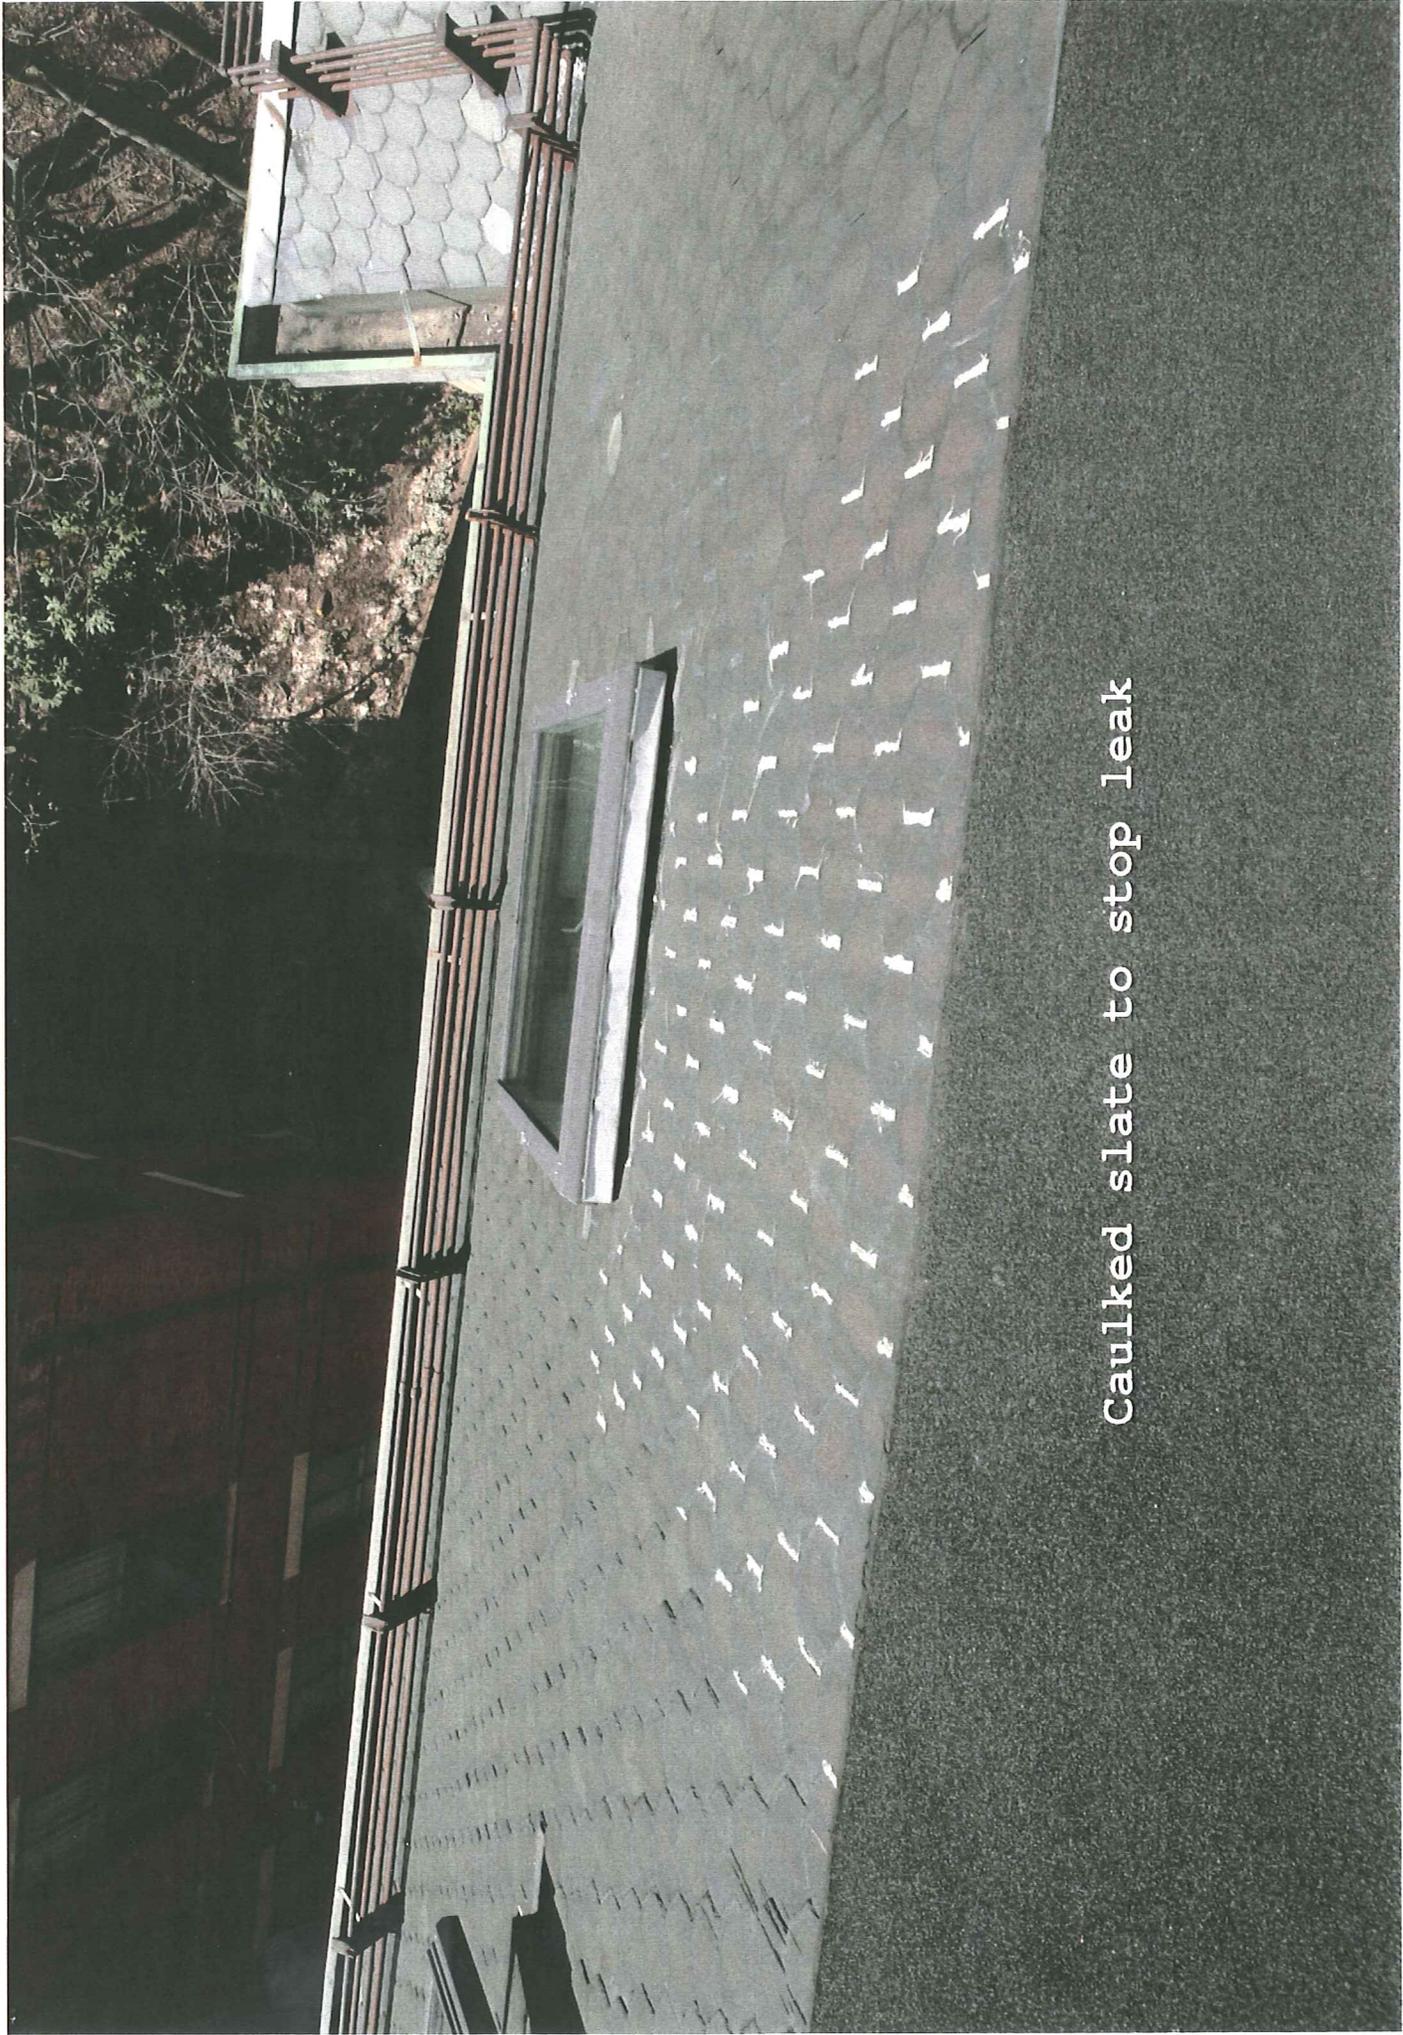
Caulked slate to stop leak

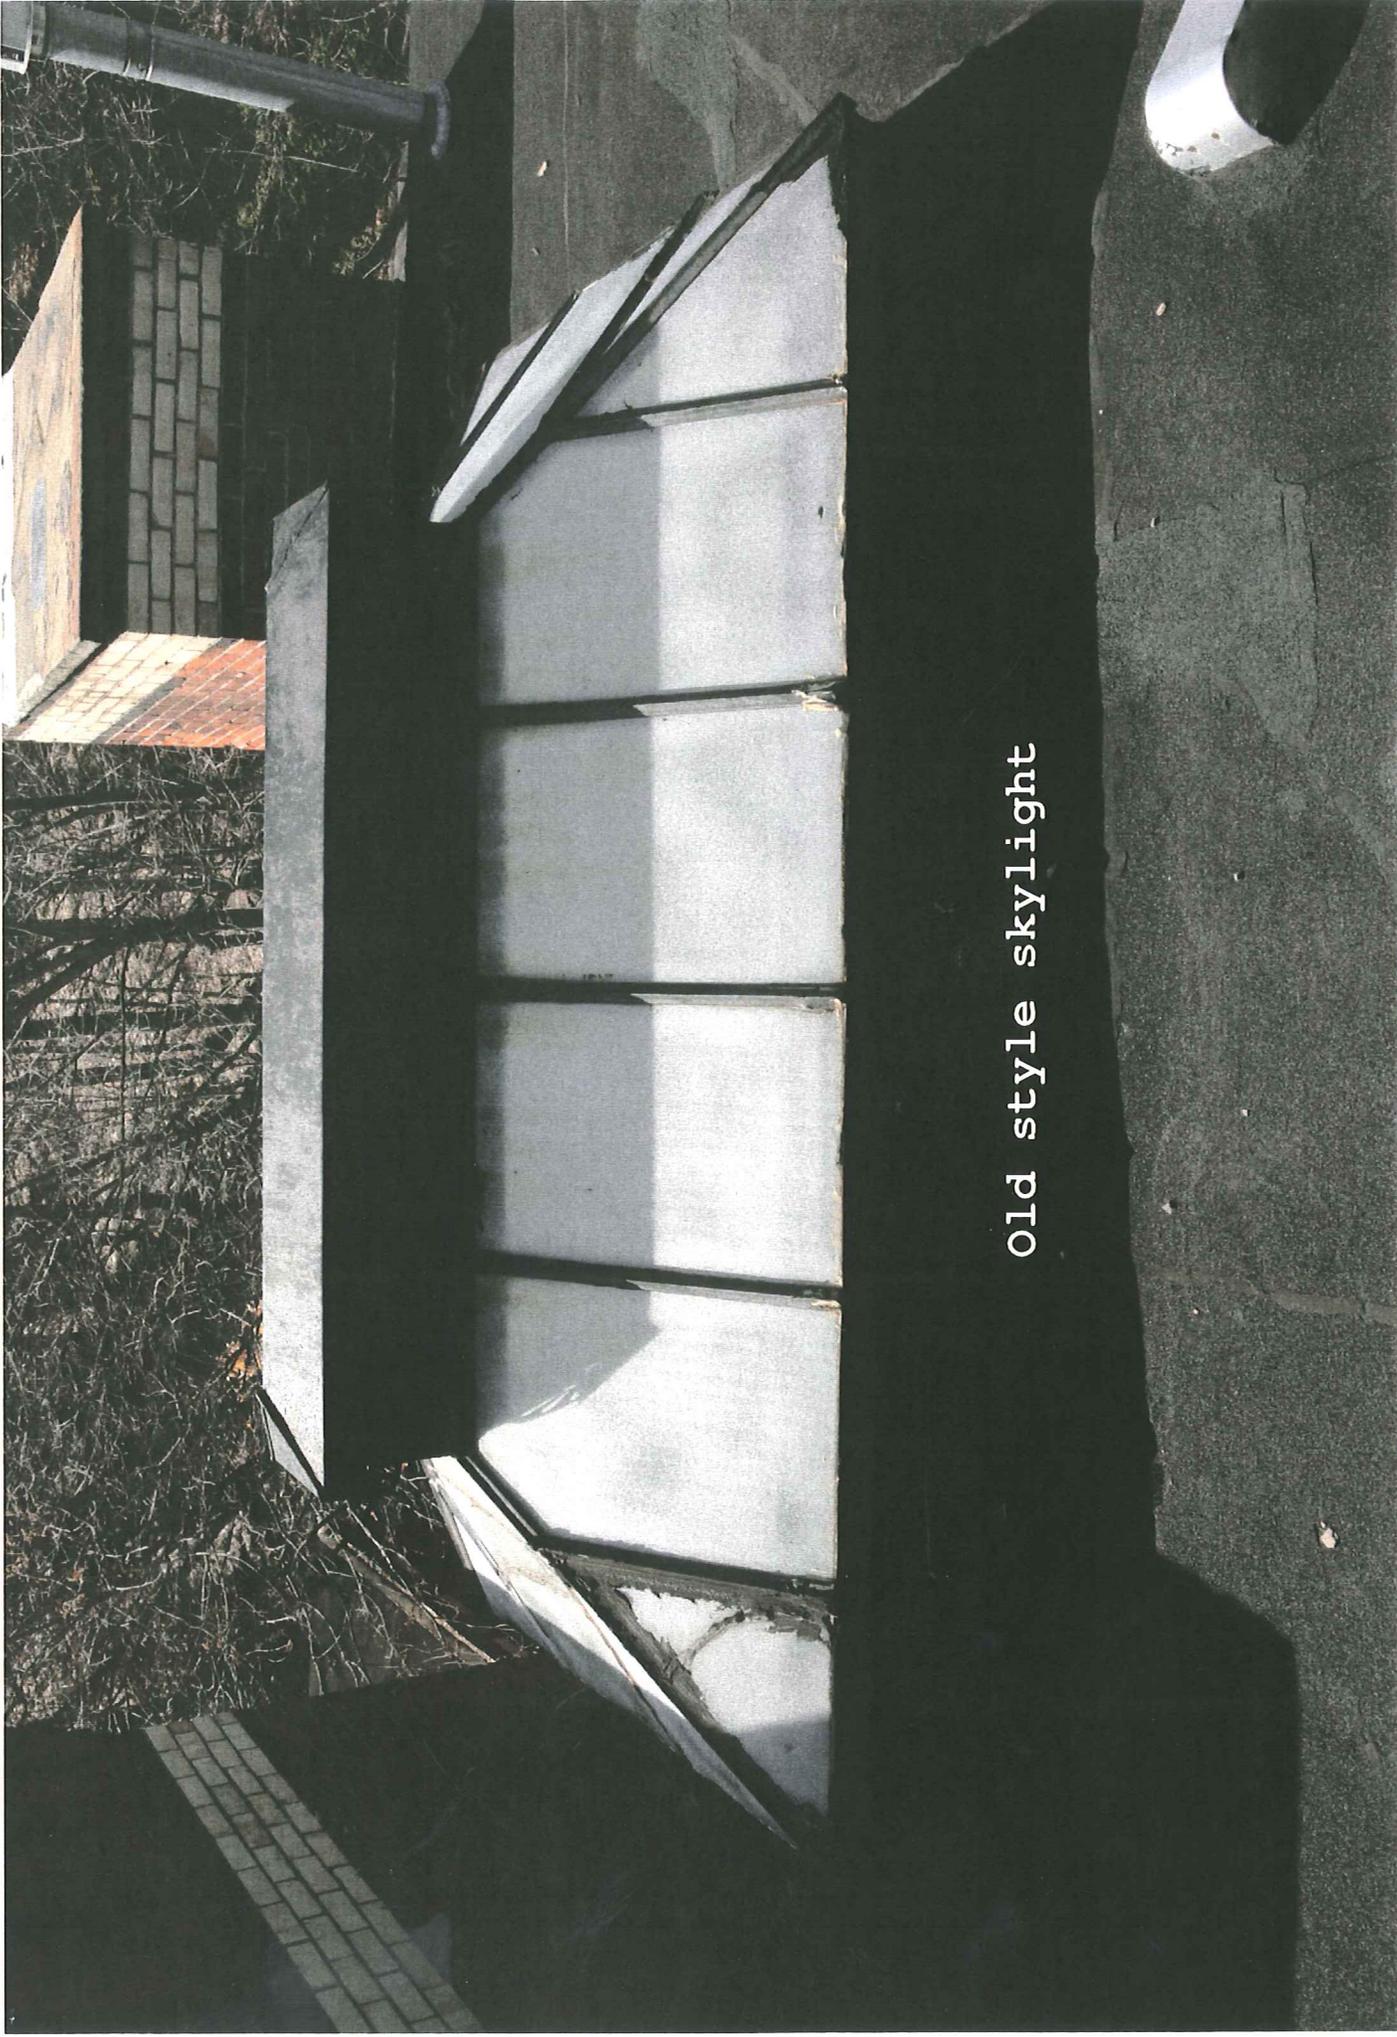
Old style skylight
