RE: Structural Engineering Consultation Services
Hillside Place Condominium, New Britain, CT

Scope of Work

HILLSIDE PLACE CONDOMINIUMS
 27 HILLSIDE PLACE
 NEW BRITAIN, CONNECTICUT

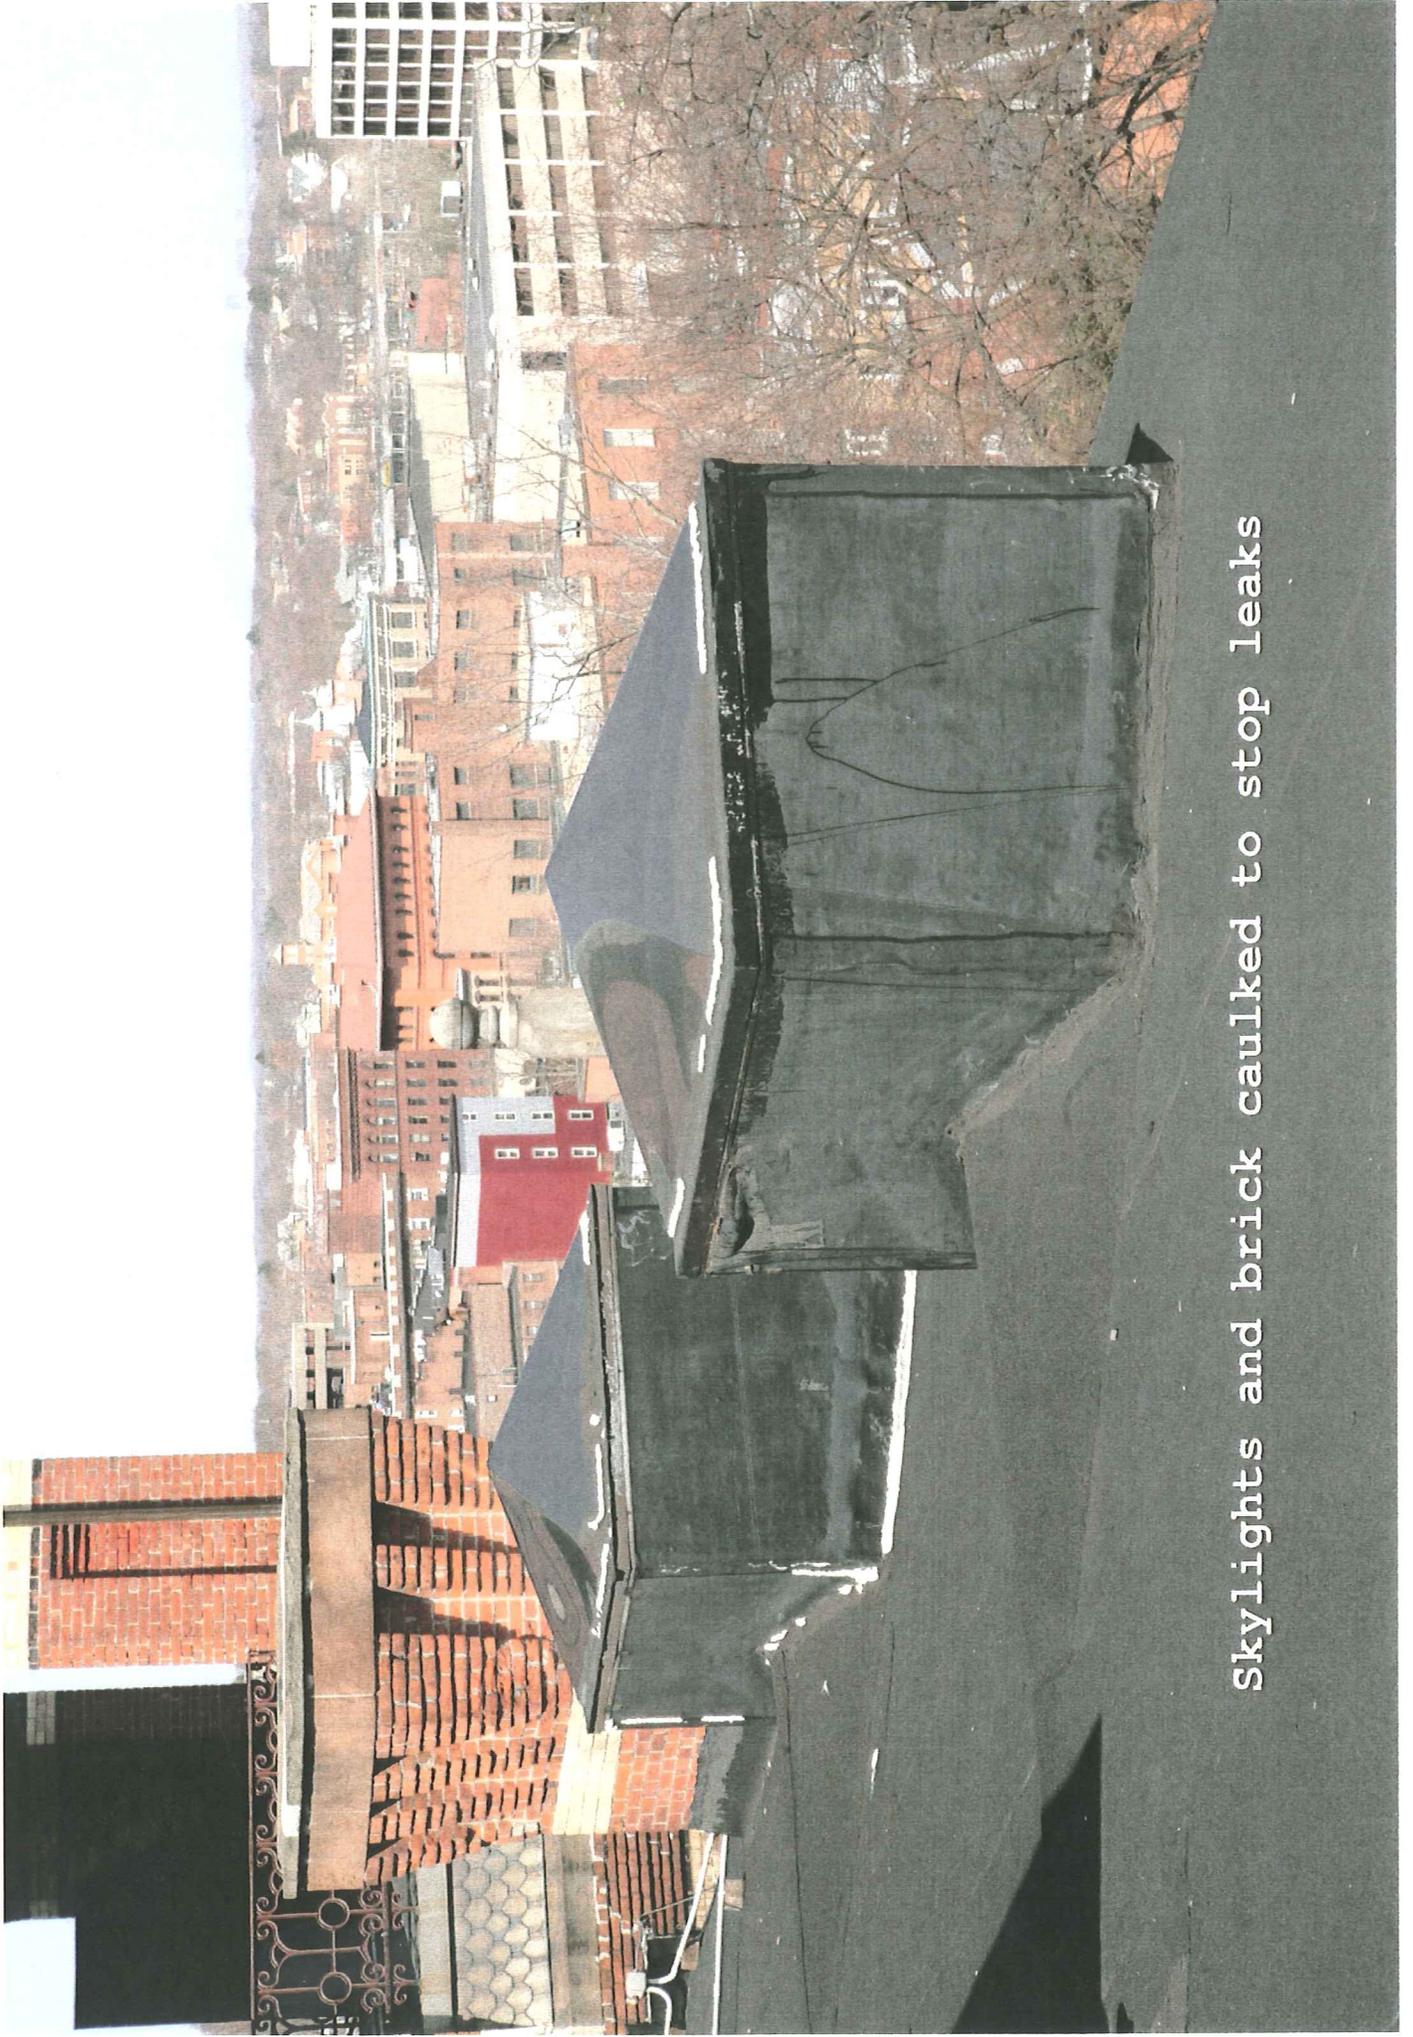
Skylights and brick caulked to stop leaks

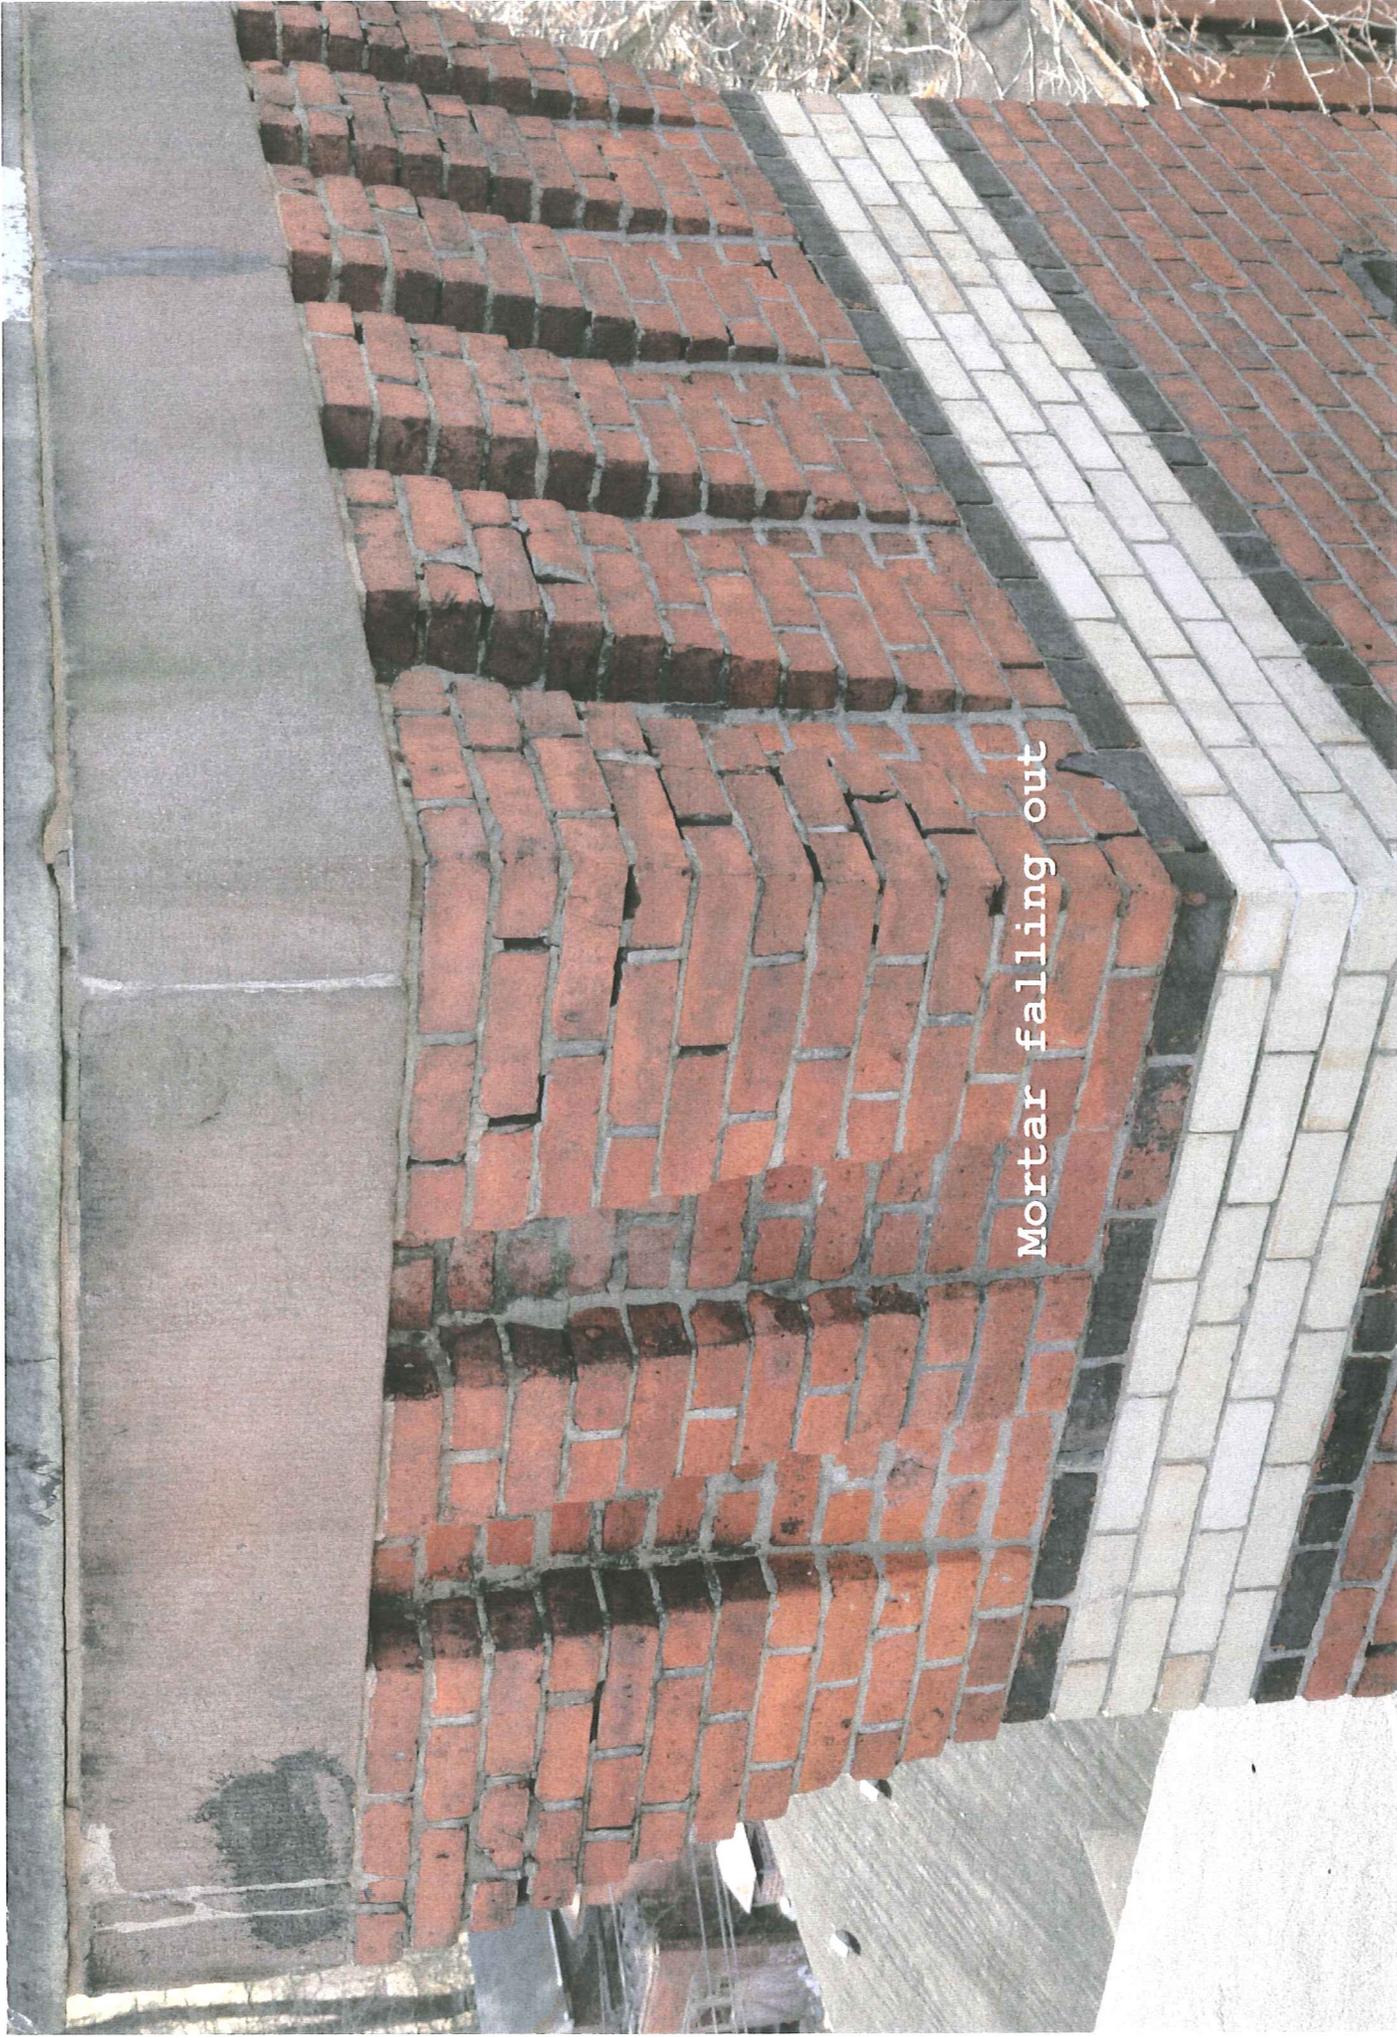
All of the chimneys have been decommissioned and have been capped with flat stone. Of great concern regarding the chimneys is the sever deterioration of the brick faces and the rotting mortar. Much of the chimney mortar is turning to dust or can be pulled out by hand.

Mortar falling out

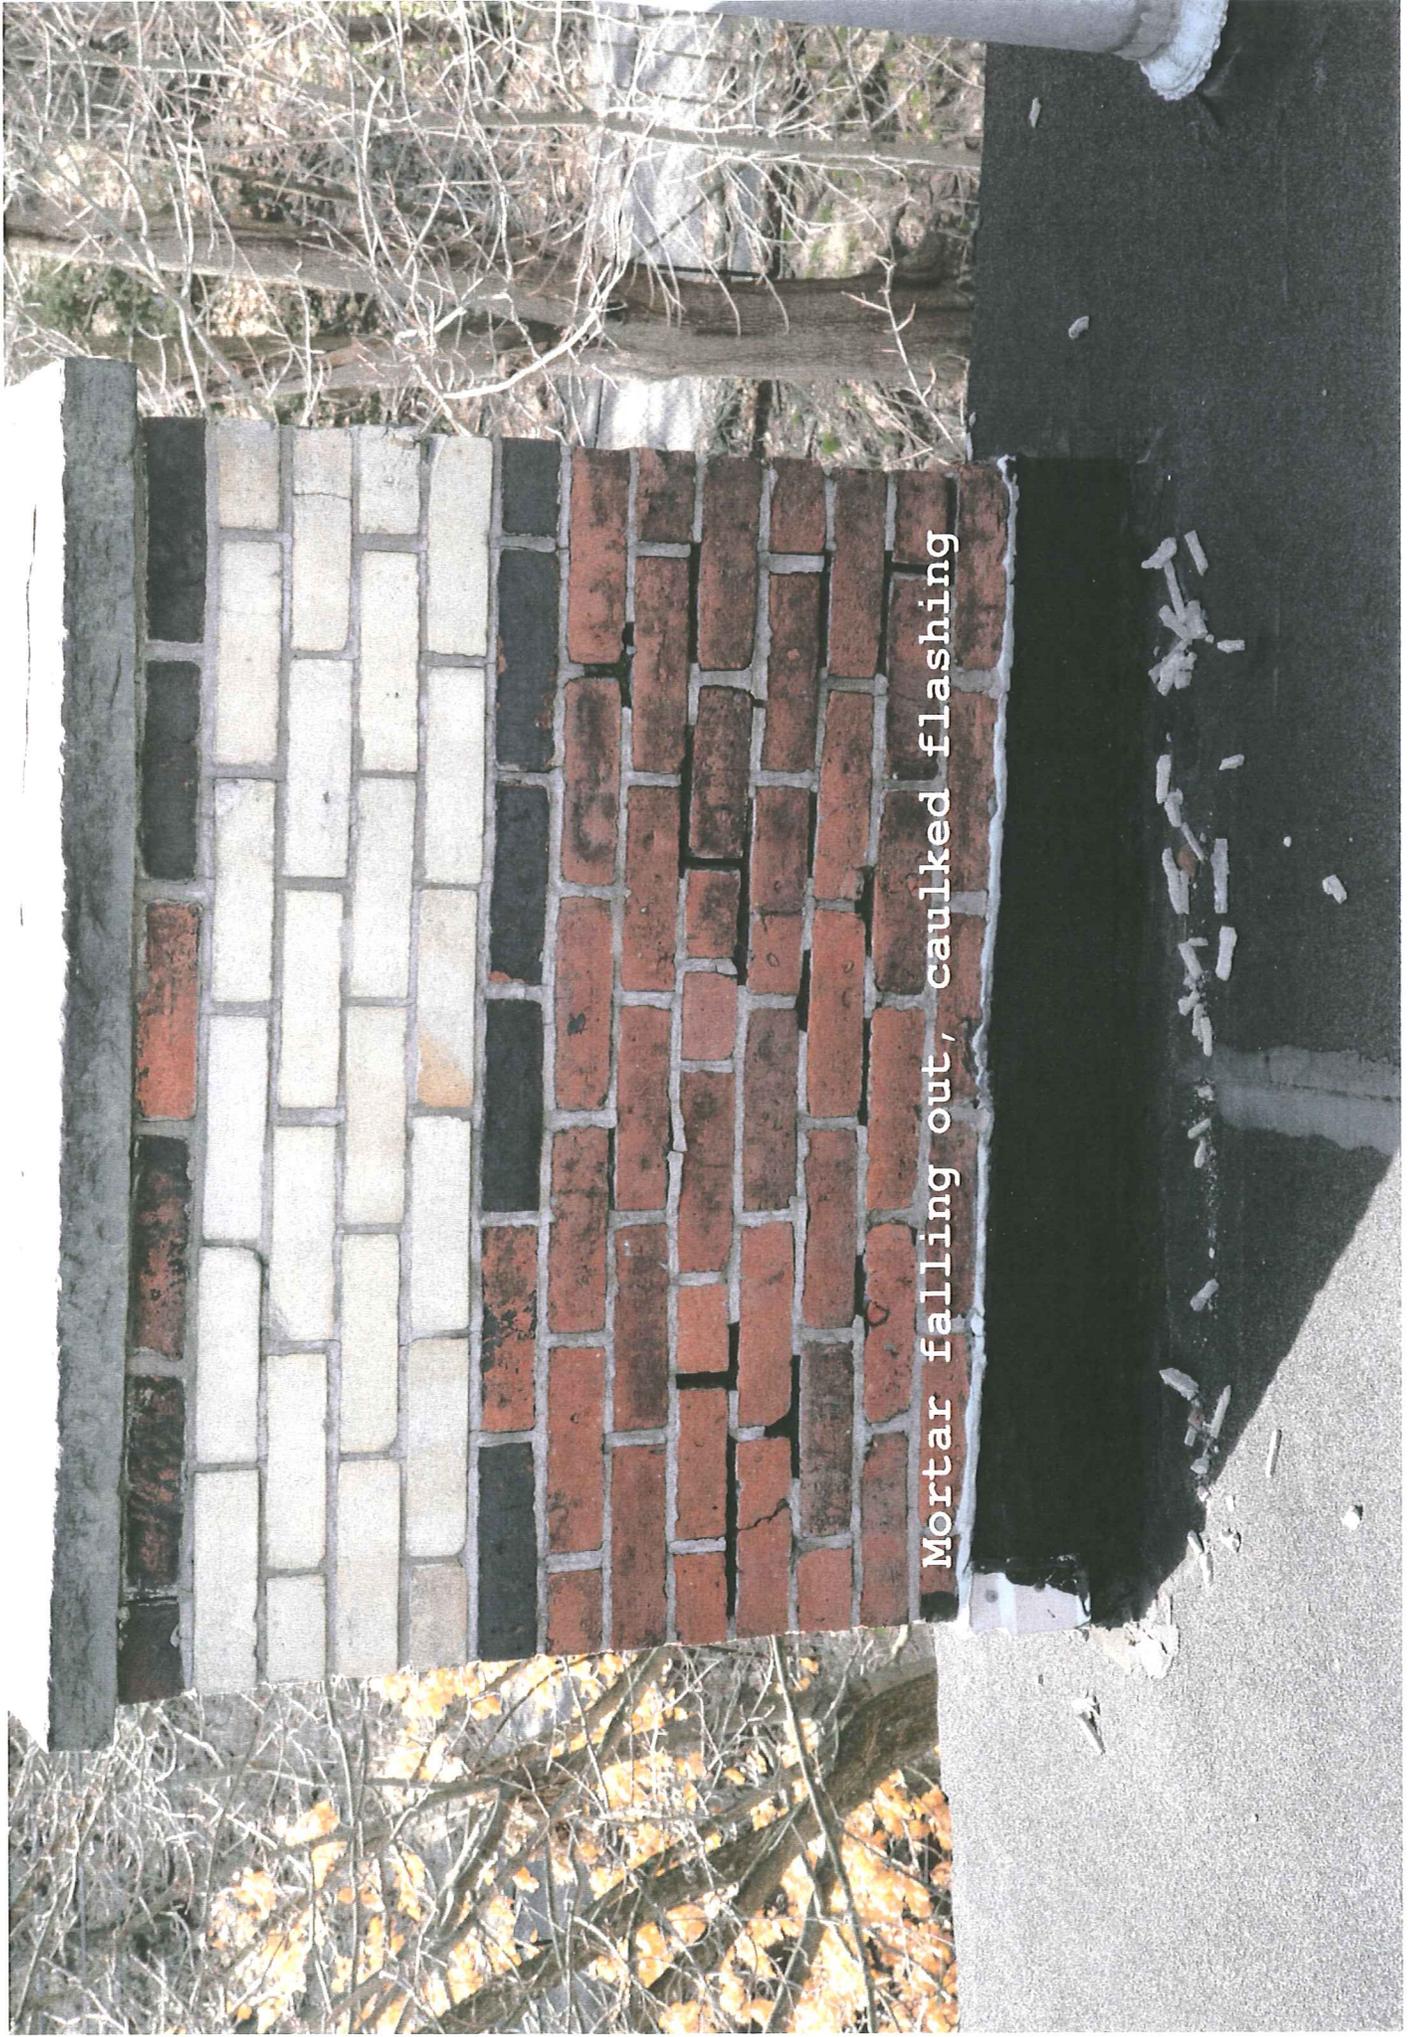
Mortar falling out, caulked flashing

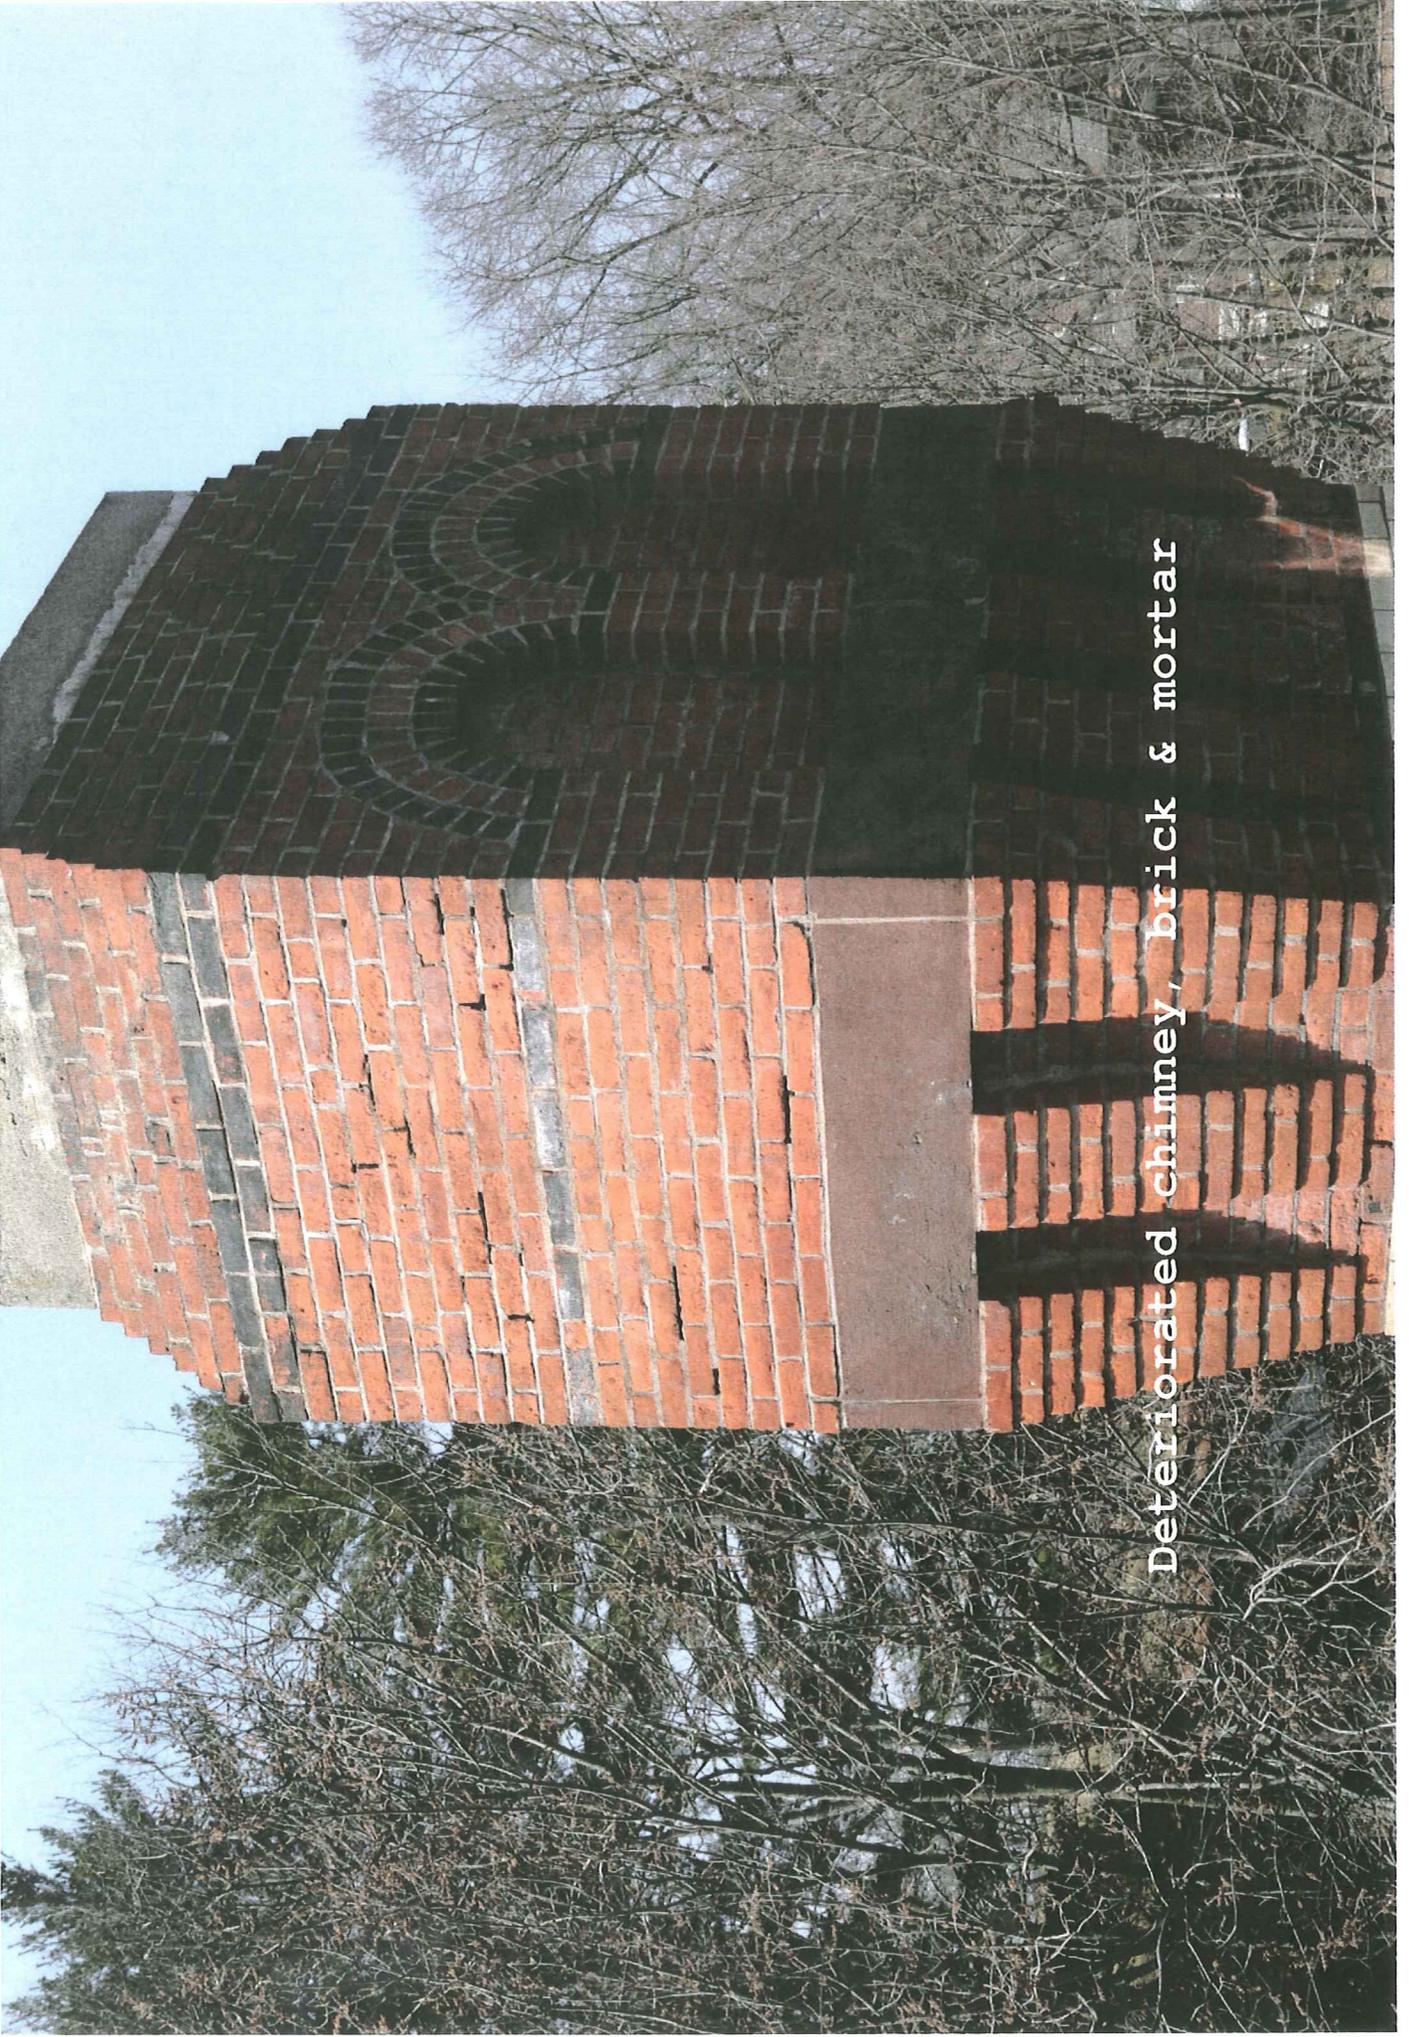
Deteriorated chimney, brick & mortar

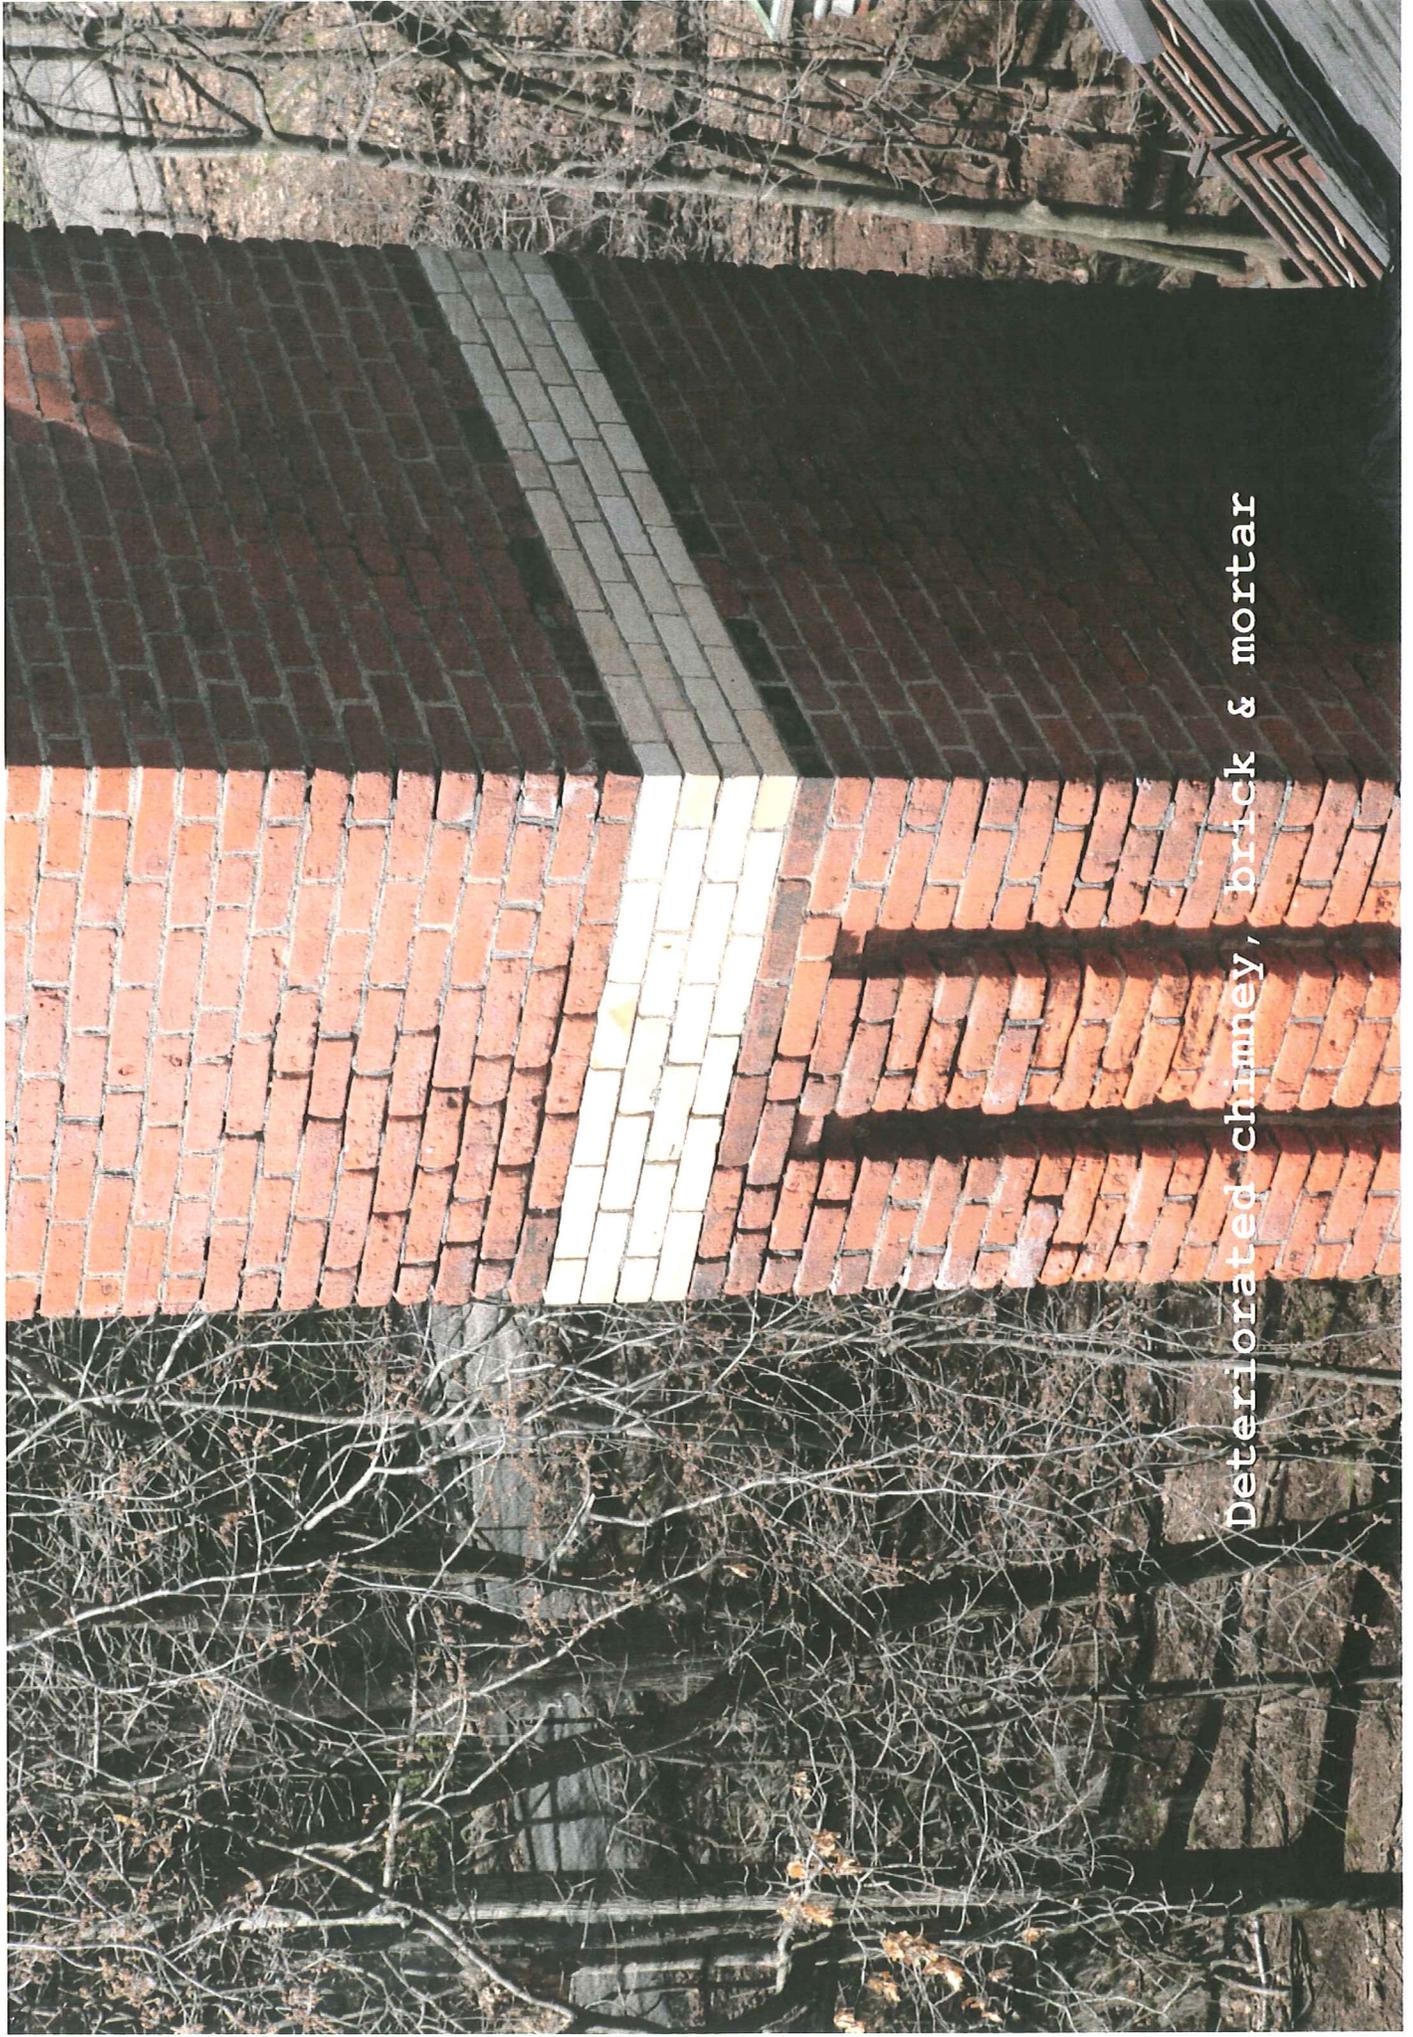
Deteriorated chimney, brick & mortar

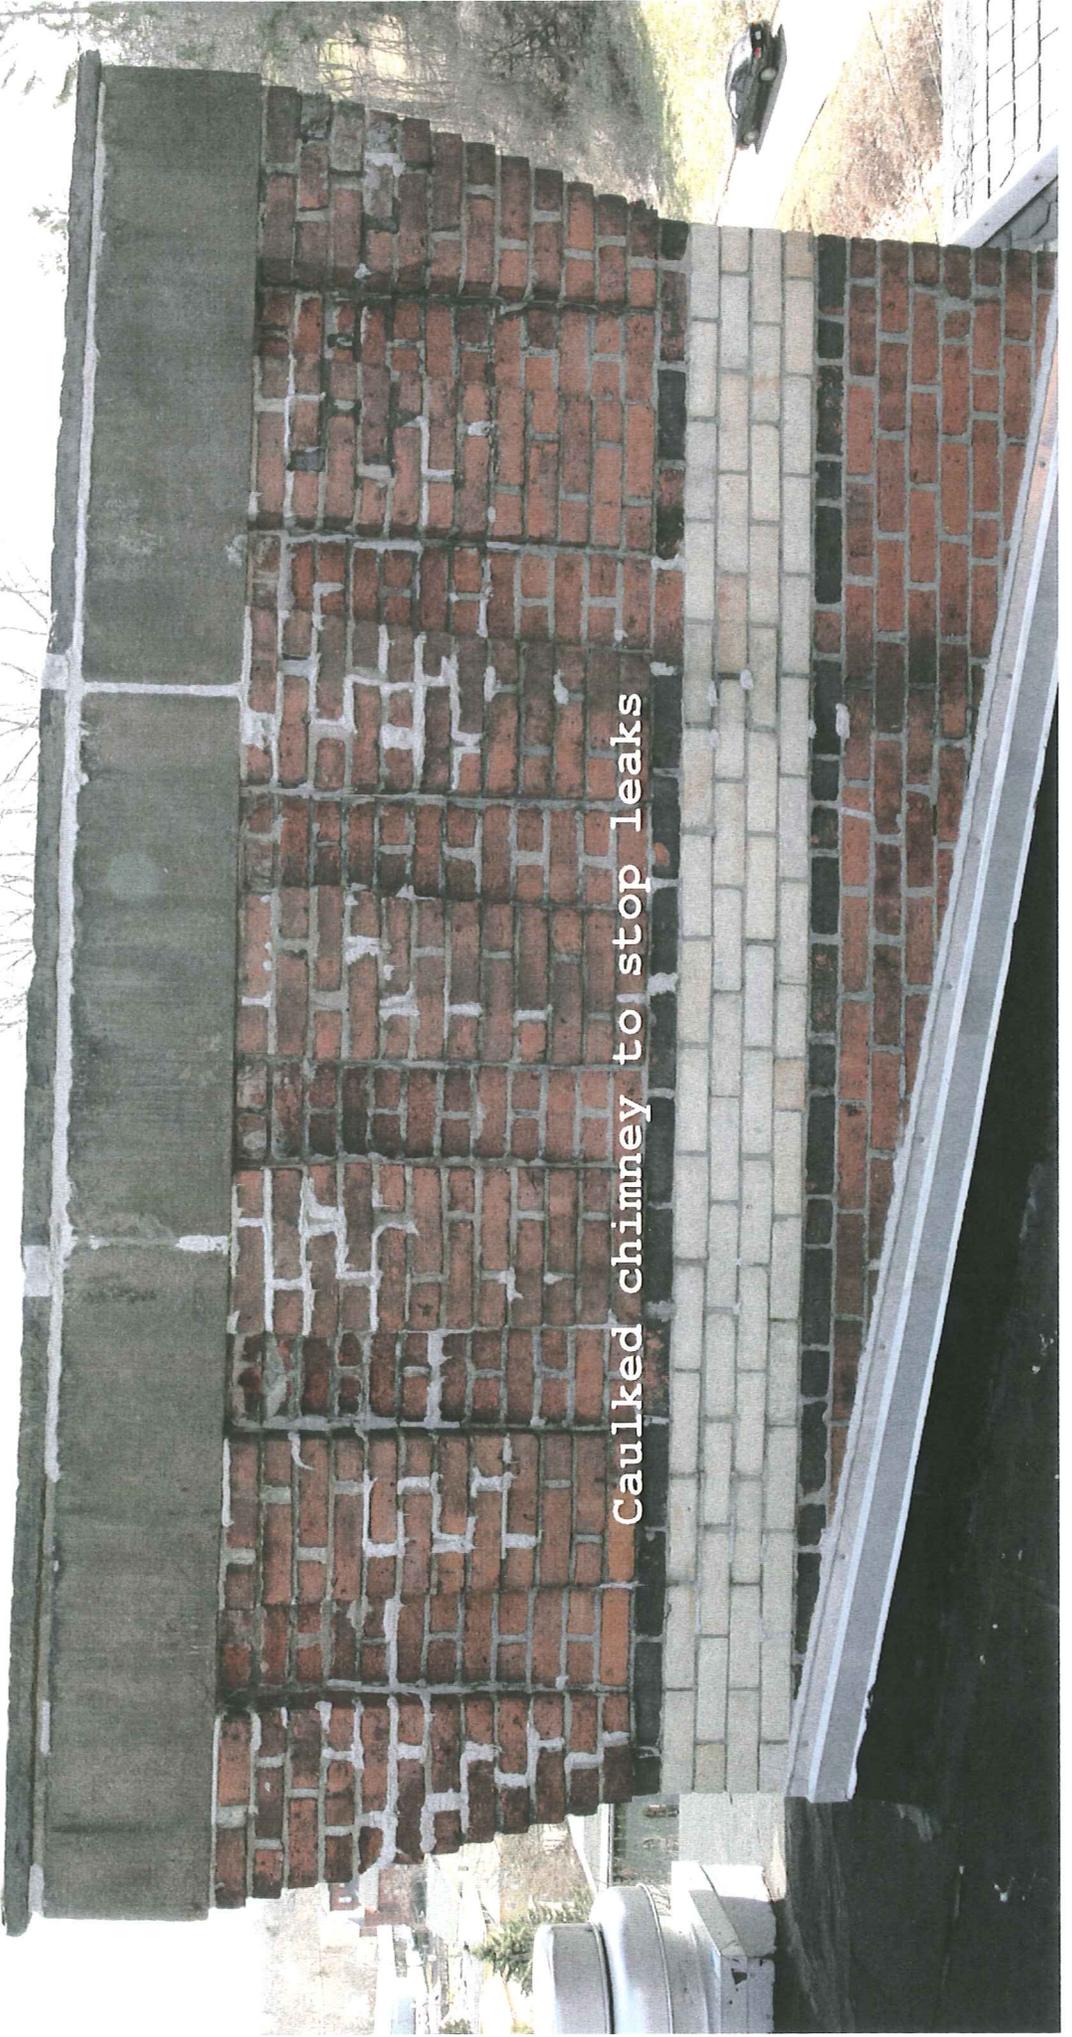
Caulked chimney to stop leaks

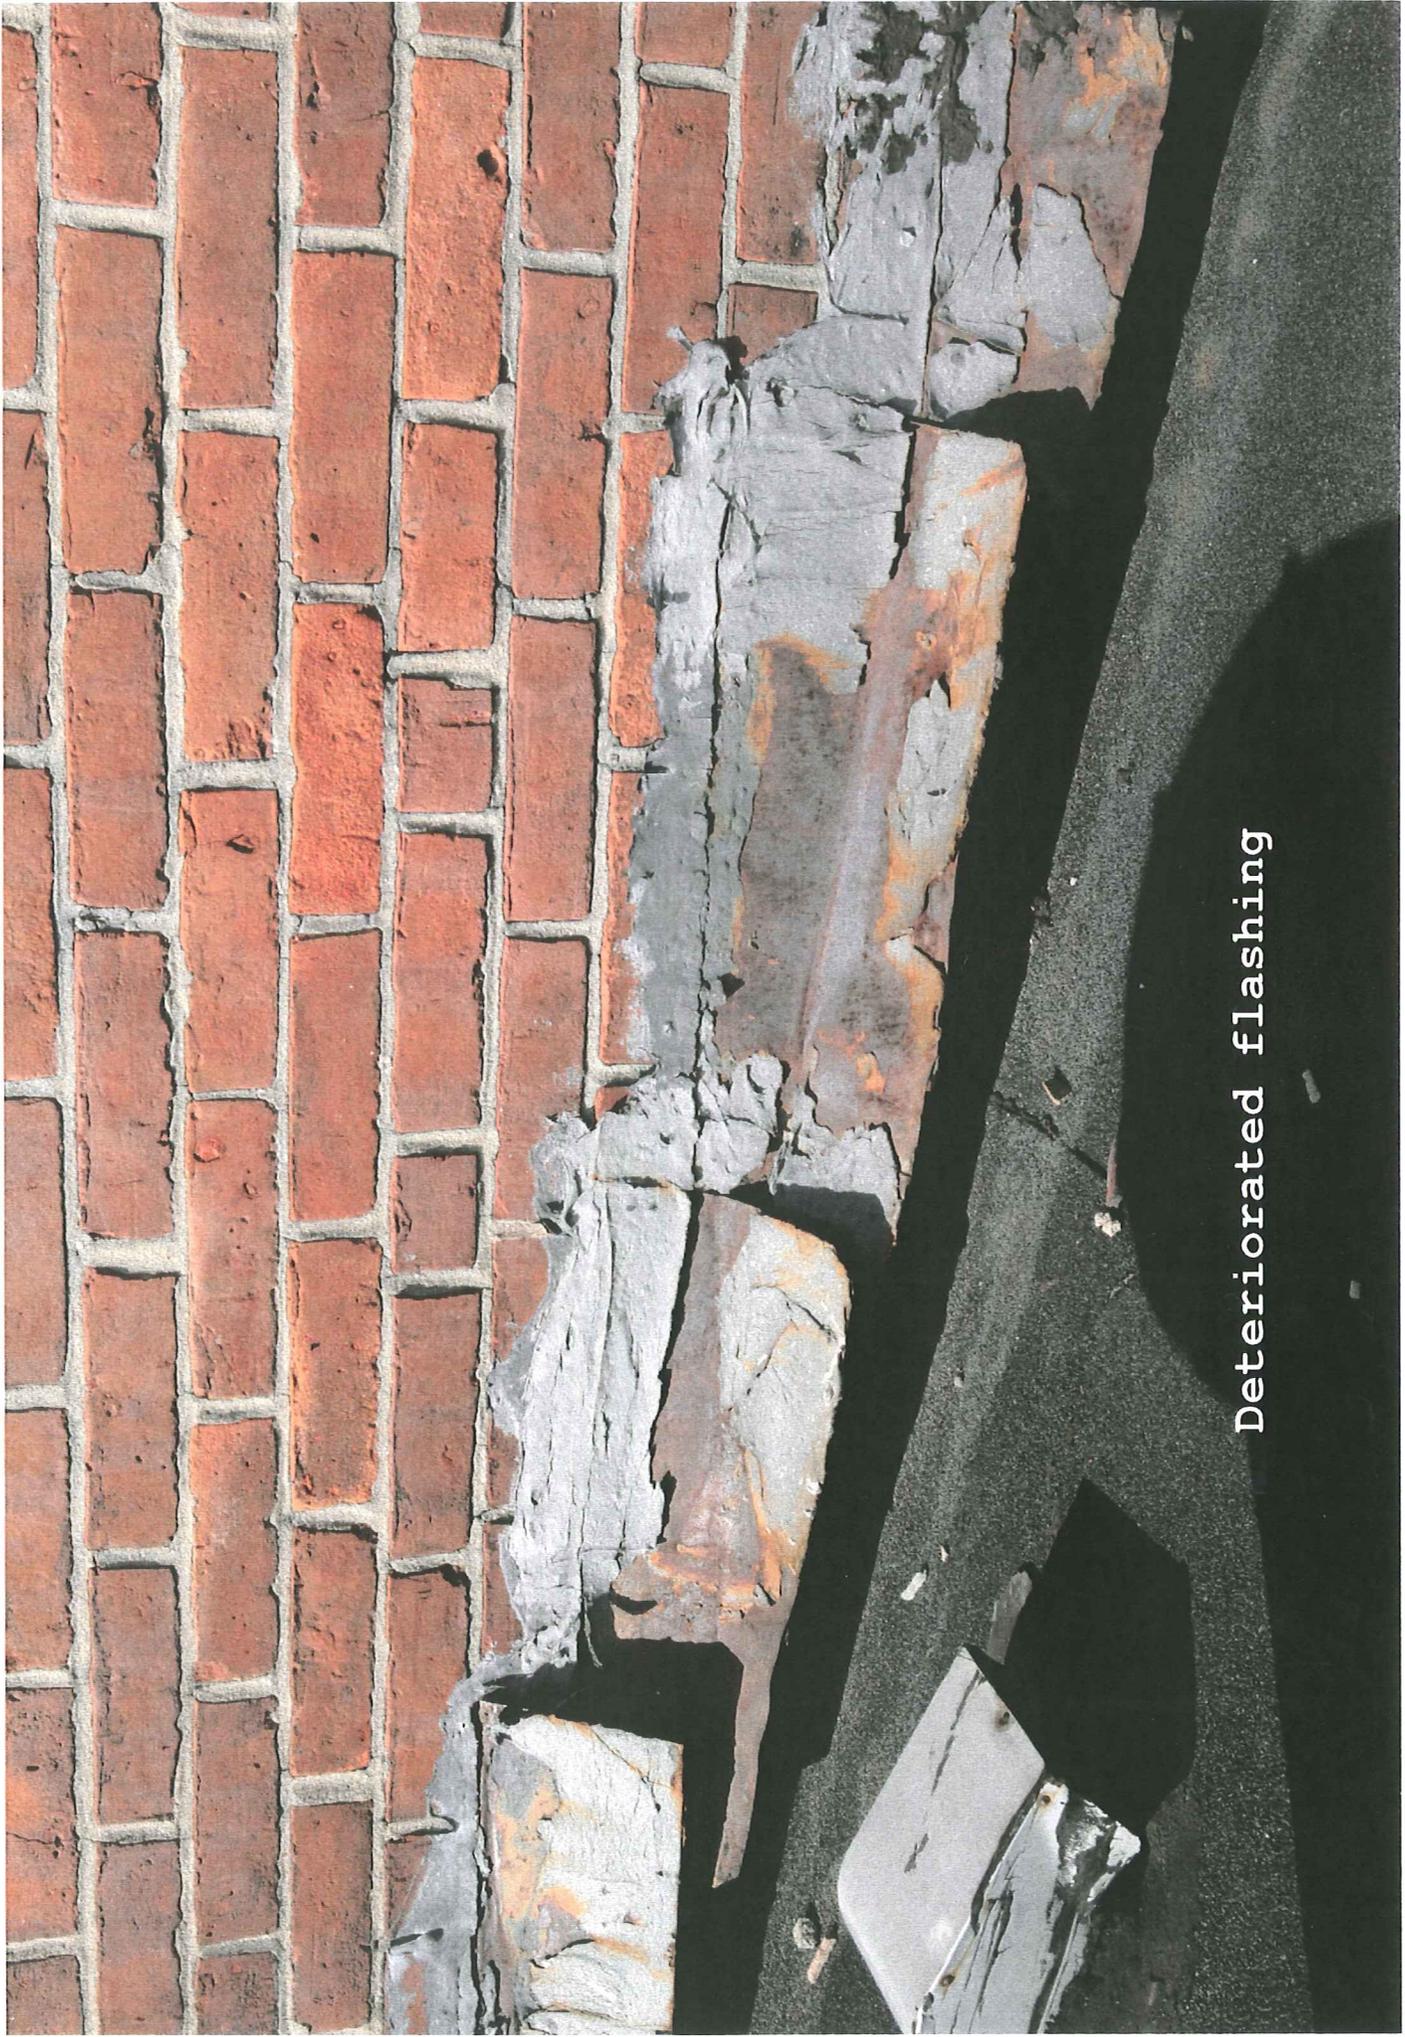
Deteriorated flashing

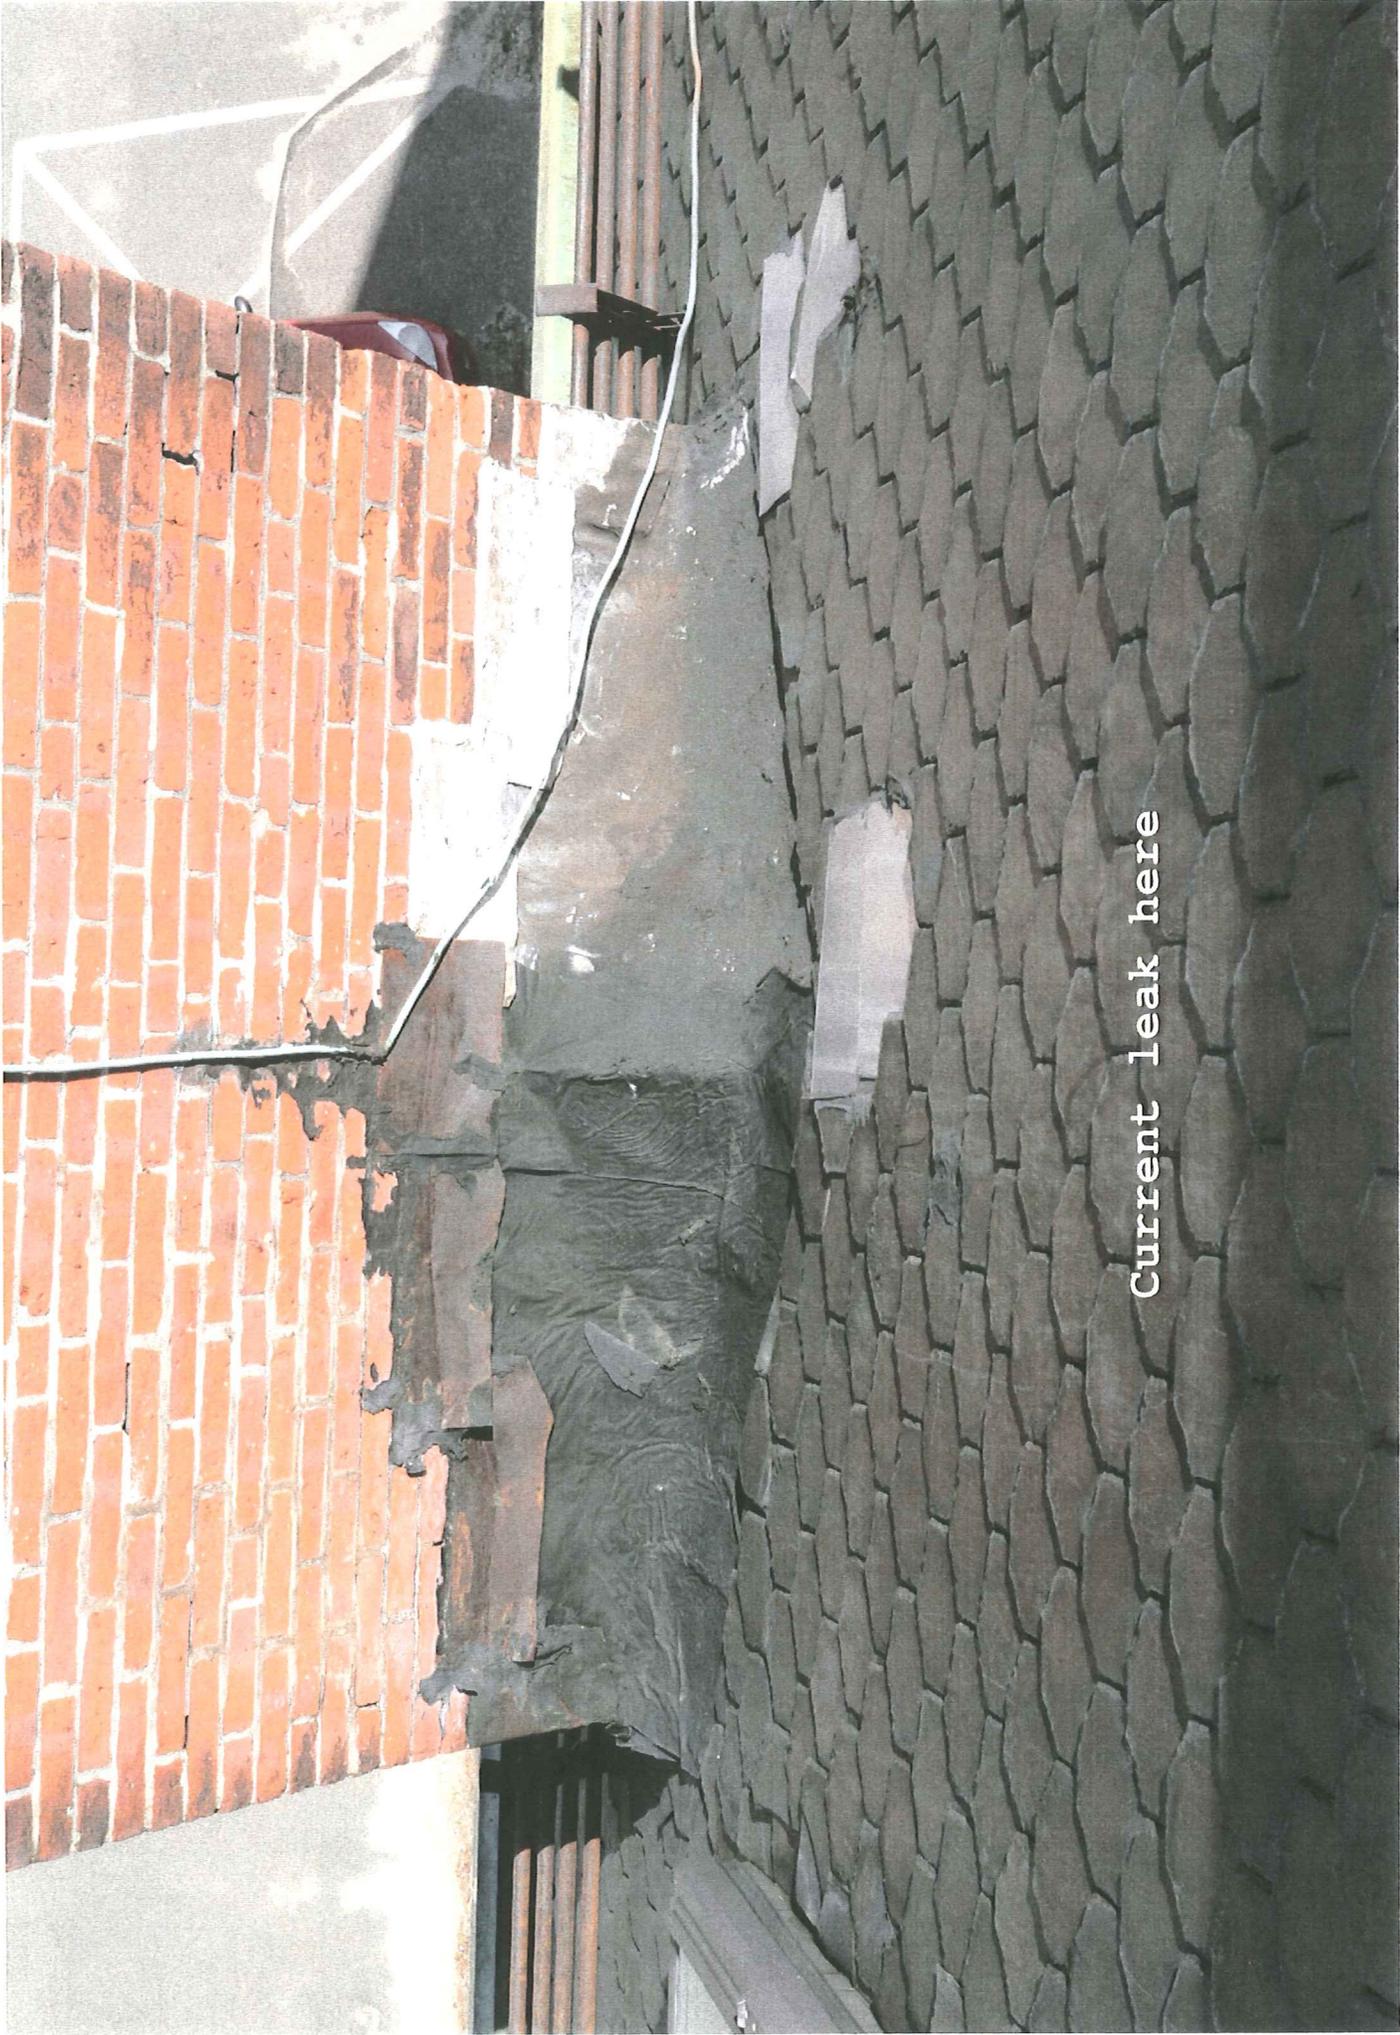
Current Leak here
