Wilton Fire Department

Memorandum

Date: February 25, 2014
To: William Brennan, First Selectman
From: Ralph Nathanson, Apparatus Supervisor
Subject: Vehicle Corrosion
Cc: Mark Amatrudo, Deputy Fire Chief

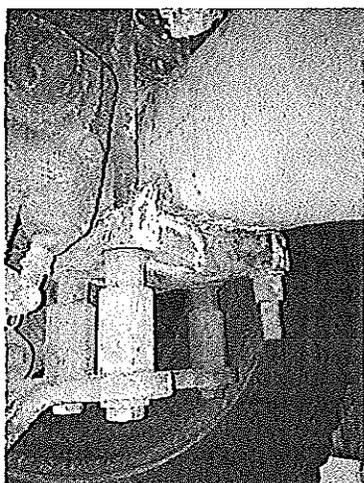
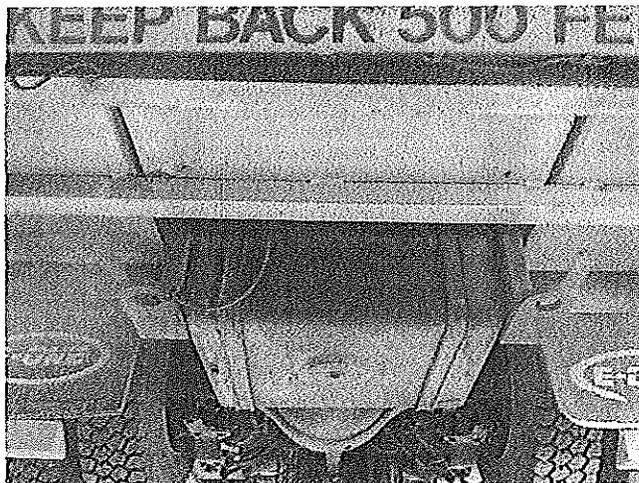
1994 Emergency One Engine (currently a reserve engine)

The 1994 Emergency One engine, which has accumulated 88k miles over the 20 years it has been in service, shows less corrosion than our 2007 engine. We believe this is due to the fact it was transferred to reserve status in July 2007. Since then, it has been housed primarily at Fire Headquarters. It goes into service when one of our other apparatus is out of service for maintenance or repairs, special detail assignments, fire standby or storm duty, etc.

When the pictures below are compared to those of our 2007 Engine 2, it is clear that there is significantly less corrosion and rust, even though the 1994 engine has been in service for twice as many years.
