UIL HOLDINGS CORPORATION

*Connecticut Legislature
Tropical Storm Irene Hearing
September 19, 2011*

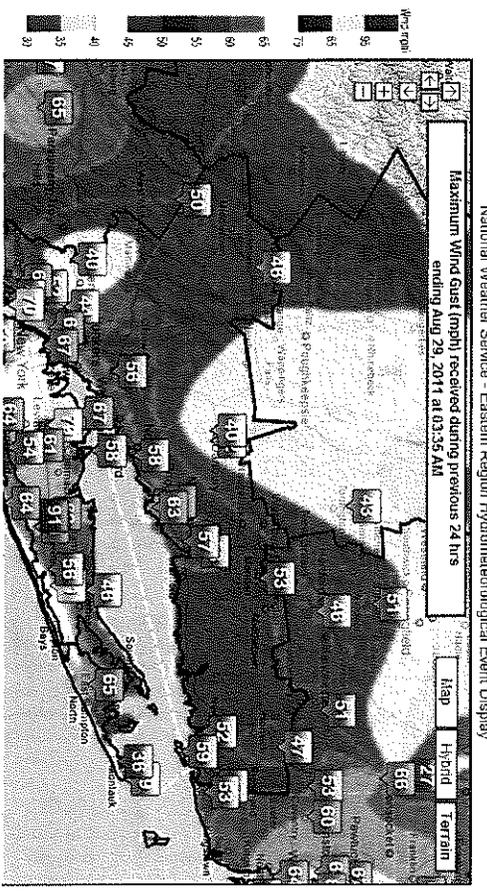
Wind Gust Map with Point Data

Storm Severity:

- 3-6" of rain
- Wind gusts > 60 mph (2 am to 2pm Su.)
- Tidal Flooding

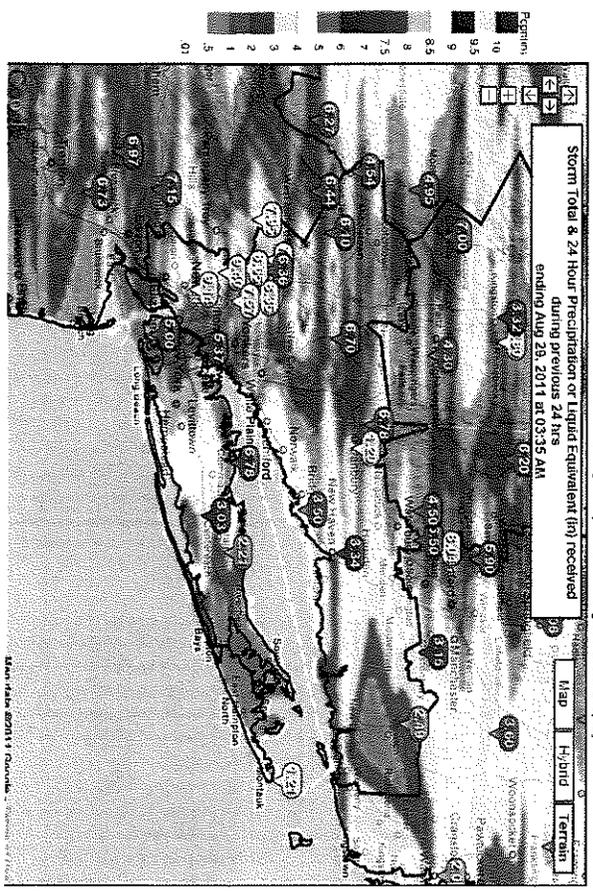
Rainfall Map

National Weather Service - Eastern Region Hydrometeorological Event Display

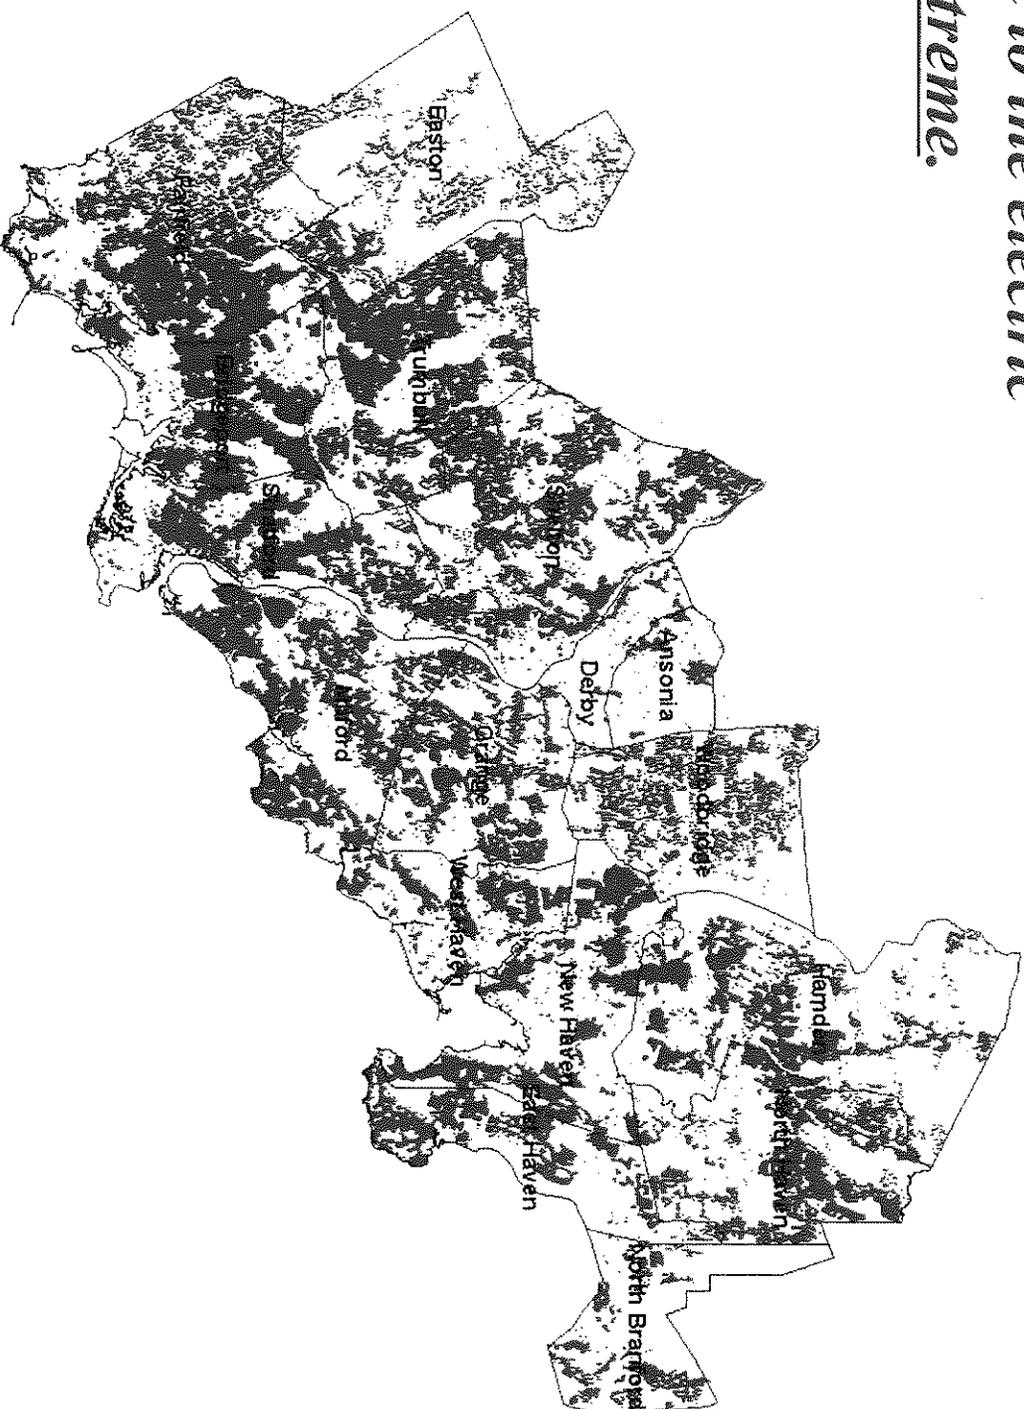
UI's Distribution System Outages*
(UI's System: 443 circuits, 3,275 miles of O/H lines)

Damage:

- 263 circuits w/ outages
- 10,300 locations worked by crews
- 9,700 locations visited to assess damage
- 158,000 peak customers out

* Total outages shown – includes all over duration of storm and recovery/restoration period.

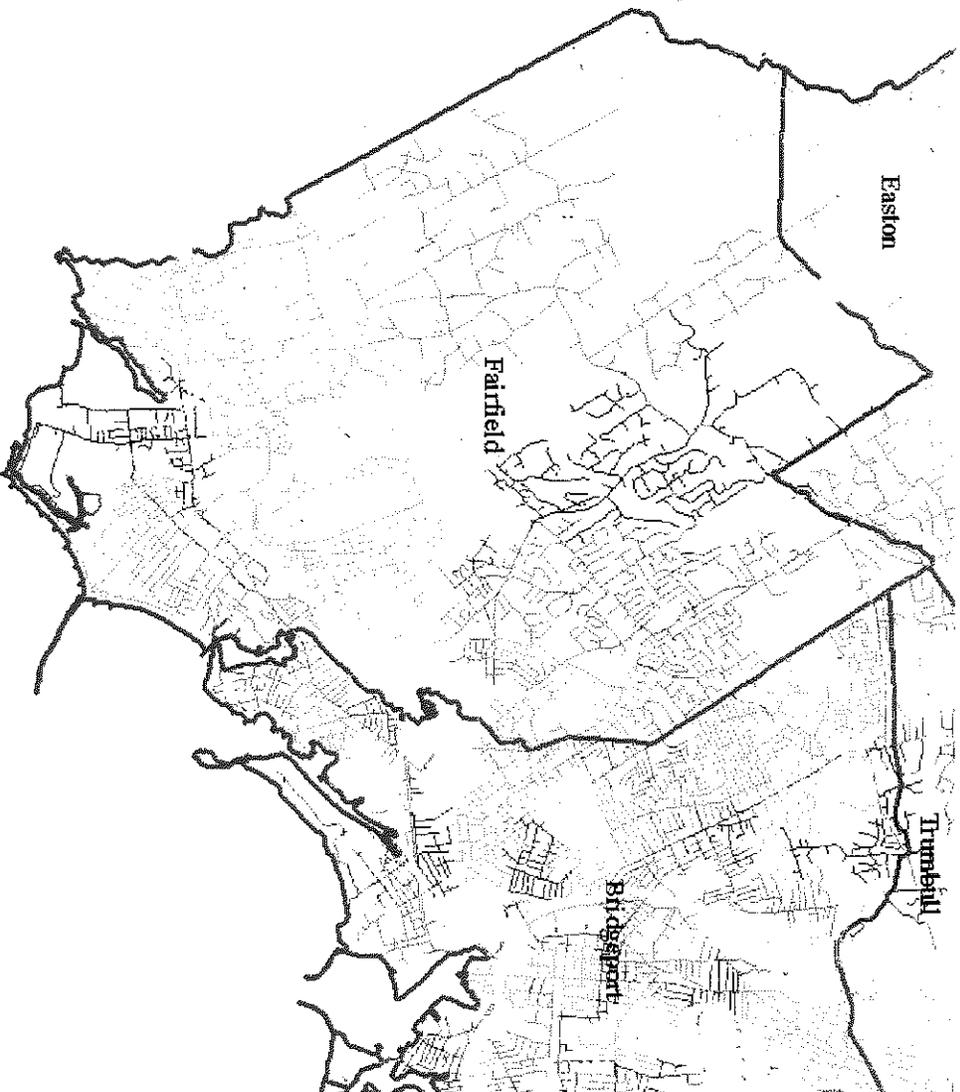
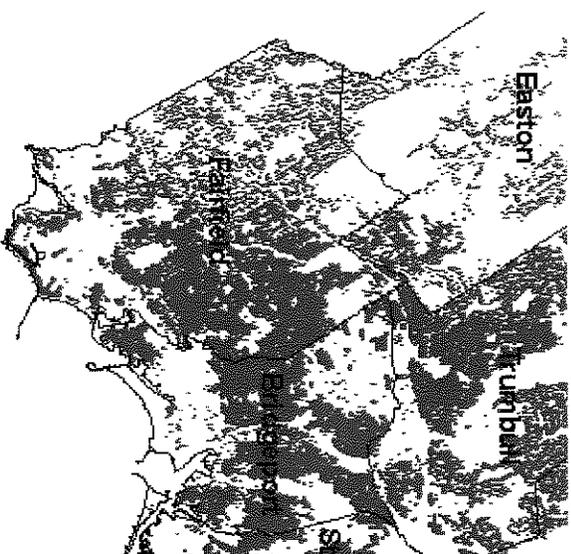
UI's Distribution System in Fairfield

Damage in Fairfield:

- 570 interrupting devices reported open (circuit breakers, fuses, transformers)
- Each may have required 1 or more work locations to resolve.

(Fairfield is served by numerous circuits - see colors above)

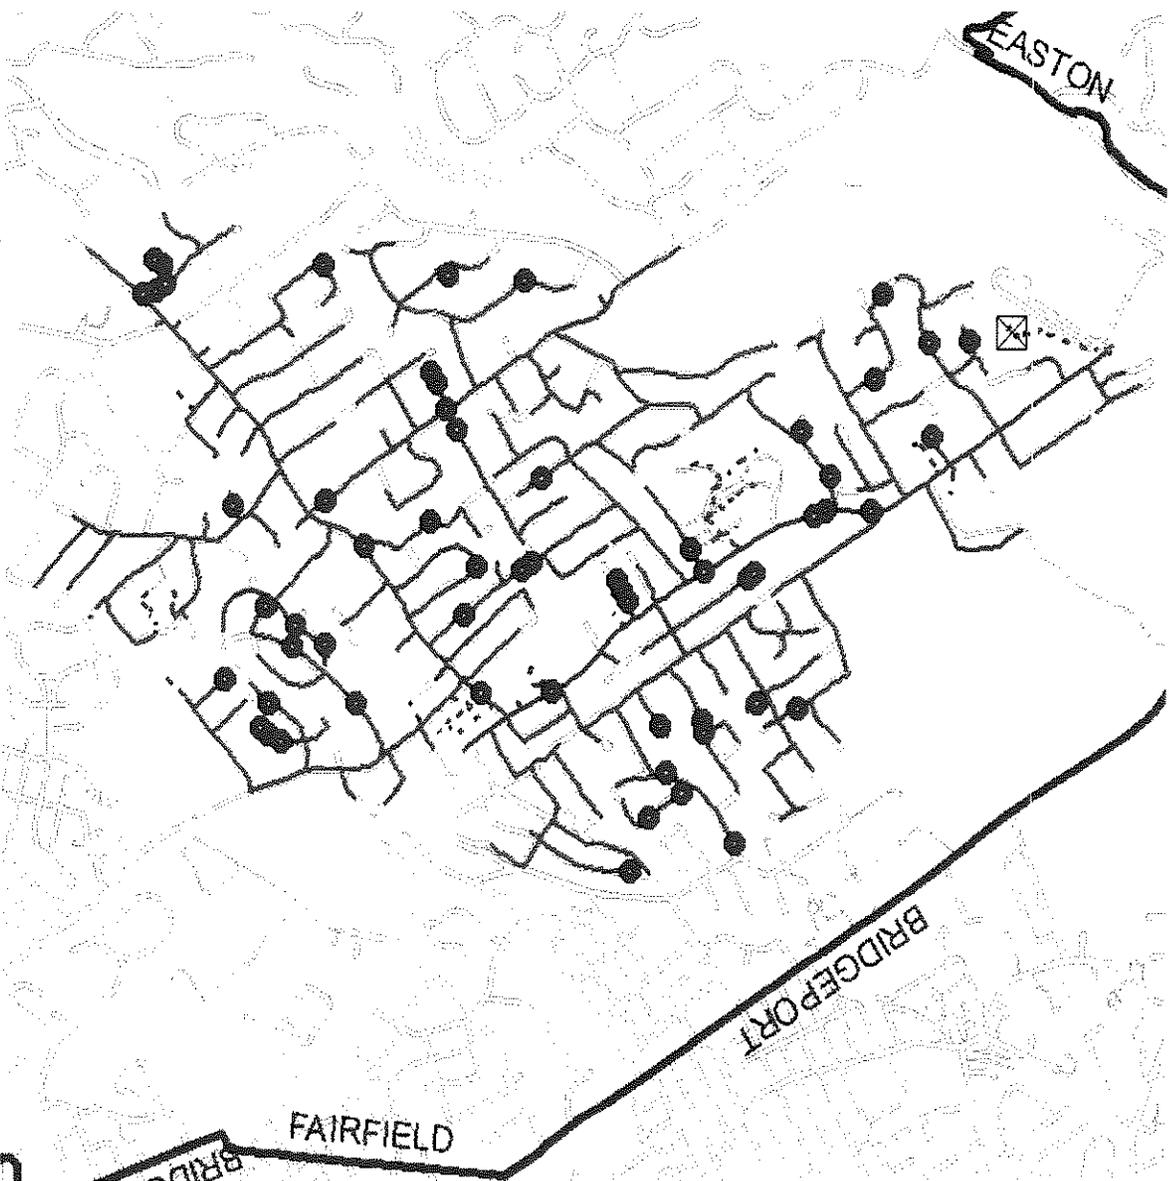
Damage – One Circuit, in One Town

Damage On One Circuit:

- In Eastern
Fairfield
- Circuit 2686
- 70 Isolating
devices reported
open
- 113 work
locations

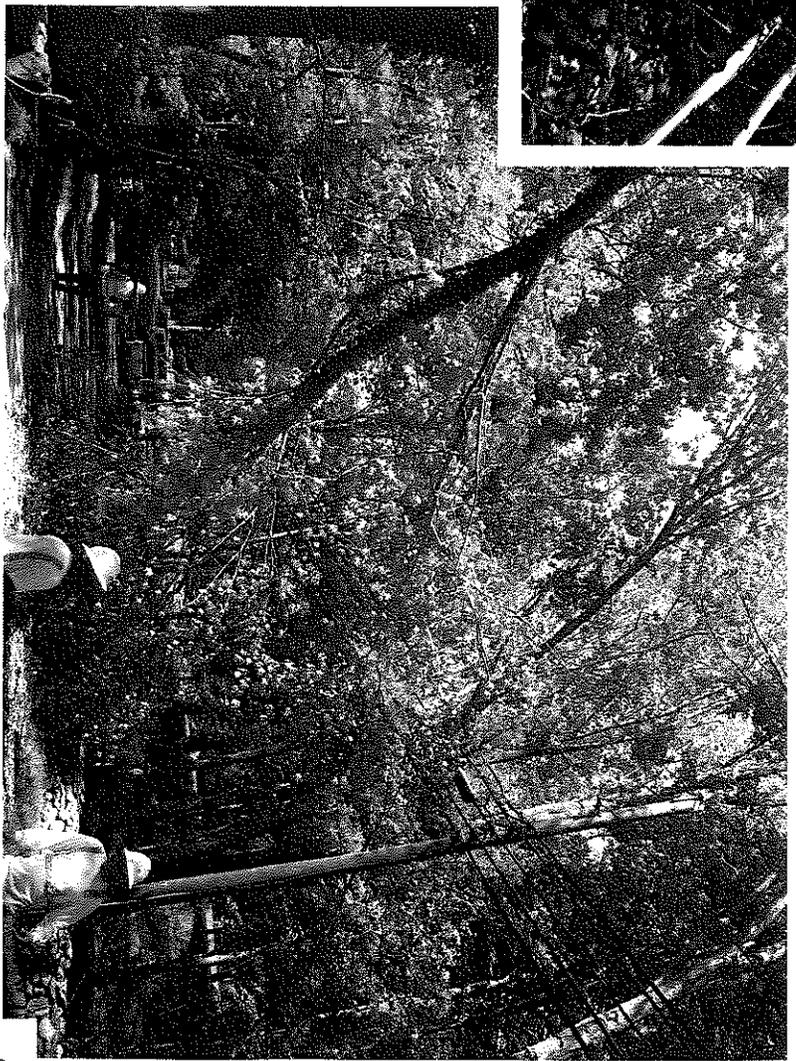
- Catamount Rd., Fairfield, CT
- In addition to the damage ...
- Note how completely the tree canopy blankets the area.
