## AGGREGATES PRONE TO CAUSING PYRITE-INDUCED HEAVE: HOW THEY CAN BE AVOIDED

M.L.J. MAHER<sup>1</sup> AND C. GRAY<sup>2</sup>

### ABSTRACT

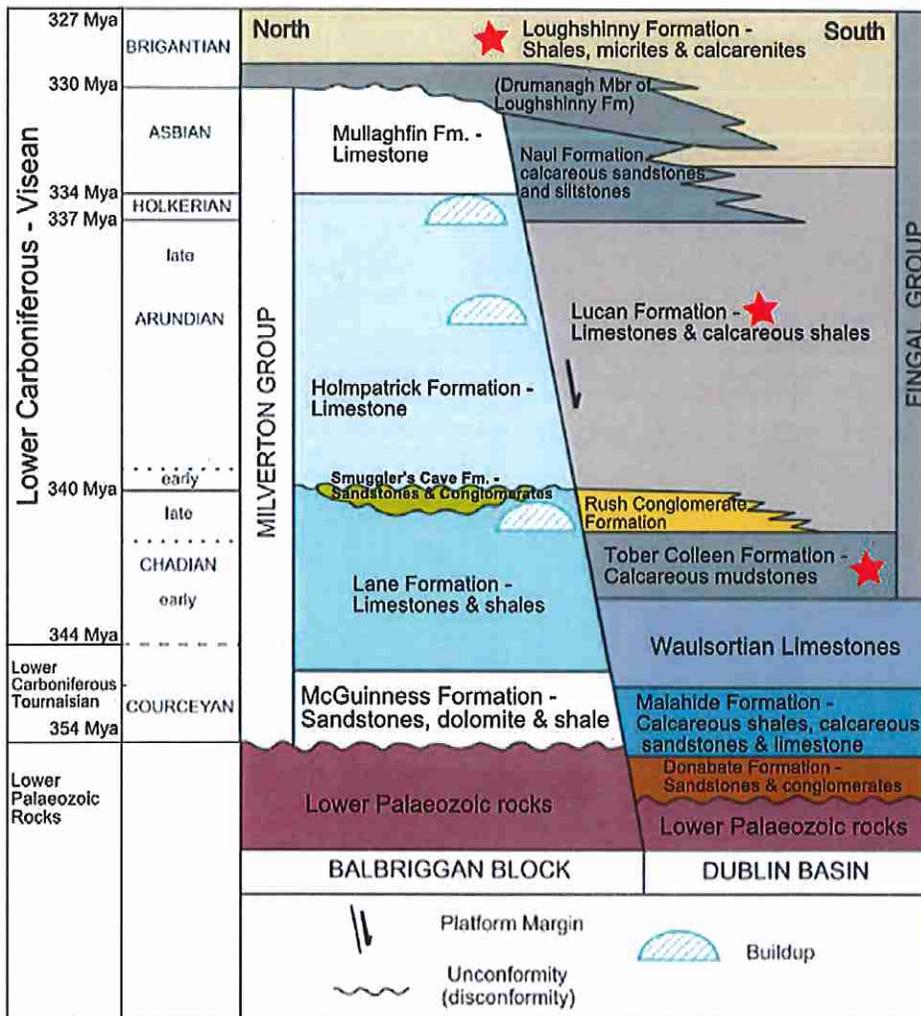
Figure 1. The Dinantian successions in north Co. Dublin (from GSI, 2001)

buildings during remedial works demonstrate that the aggregates fail to meet the Liquid Limit, Coarse Aggregate Water Absorption, Magnesium Sulphate Soundness and Ten Percent Fines Value for Clause 804. This is not surprising given the geological formations that were being exploited. One such quarry, near Dublin Airport, is located within the Tober Colleen Formation that is described as “dark grey, calcareous, commonly bioturbated mudstones and subordinate thin micritic limestones” (Geological Survey of Ireland (GSI), 2001). The Tober Colleen Formation is of Lower Carboniferous age and is the lowest unit within the Calp Limestone. Another problematic quarry was located further north within the Loughshinny Formation. This rock is described as “argillaceous, pyritic, locally cherty micrites and graded calcarenites, interbedded with dark grey to black shale” (GSI, 2001). Two further Co. Meath quarries that have supplied problematic pyritic aggregates are from the Lucan Formation and are described as “dark grey, well bedded, cherty, graded limestones and calcareous shales” (GSI, 2001). The geological succession of these various formations is illustrated in Figure 1 and aggregate appearance is shown in Figures 2 and 3.

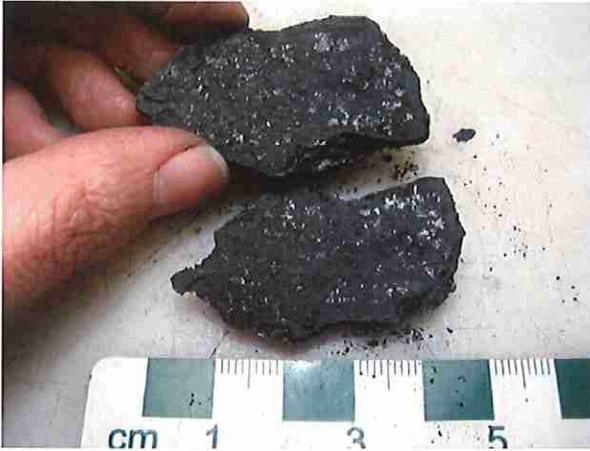
**Figure 2.** Aggregate particle from a quarry in the Tober Colleen Formation opened on a lamination revealing gypsum clusters (white flecks).

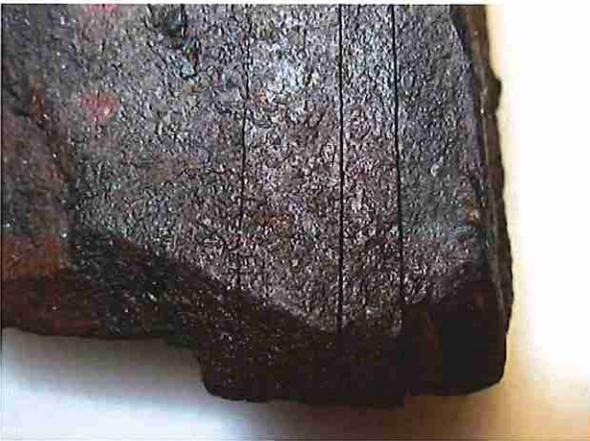
**Figure 3.** Aggregate particle from five-year old hardcore with laminations propped open with gypsum.

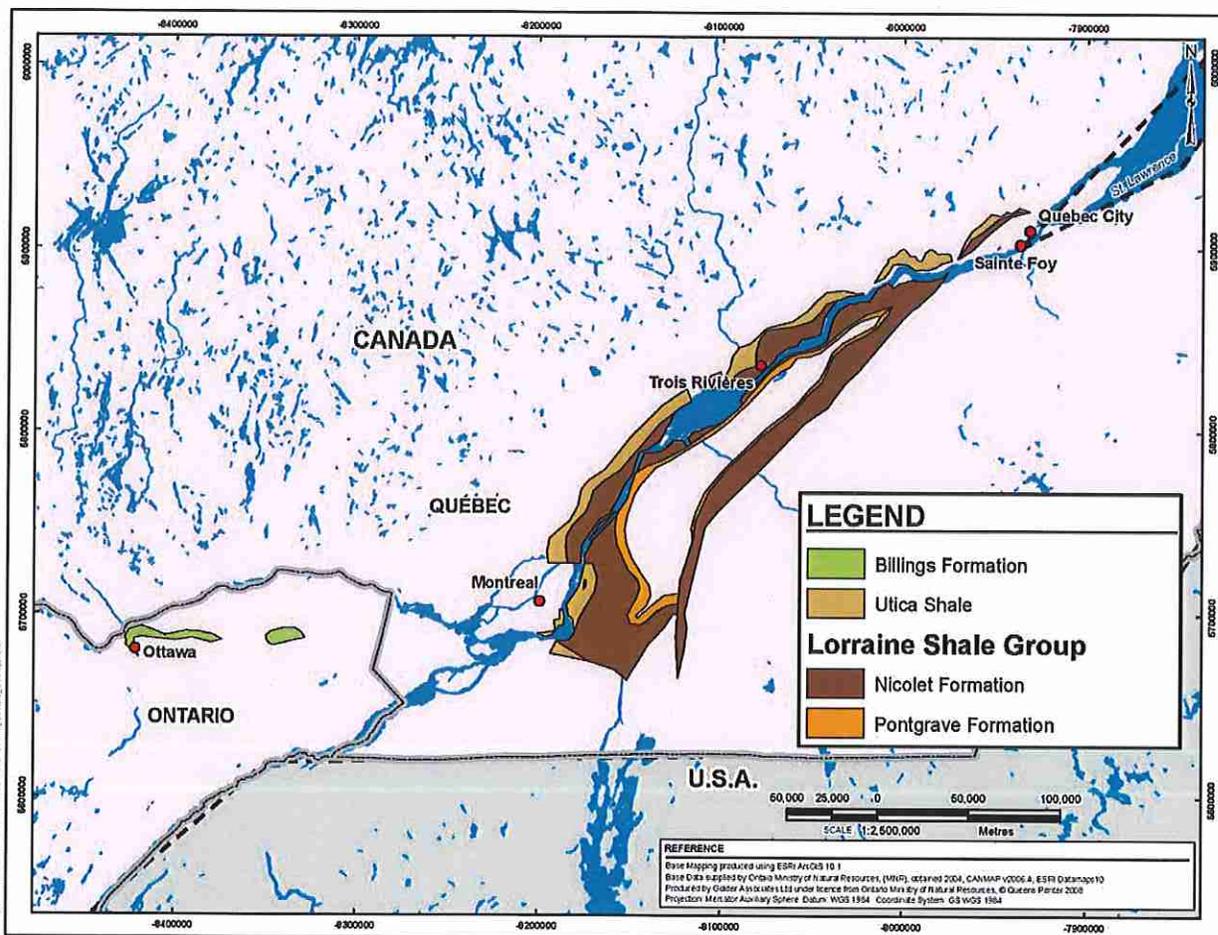
Figure 5. Extent of shale bedrock in areas reporting pyrite-related problems (from Ontario Ministry of Natural Resources, 2008).

When the geological mapping for these areas is examined (Figure 5), it is seen that the affected areas are characterized by shale deposits. This is consistent with the published literature on pyrite-related problems around the world where they are associated with areas of

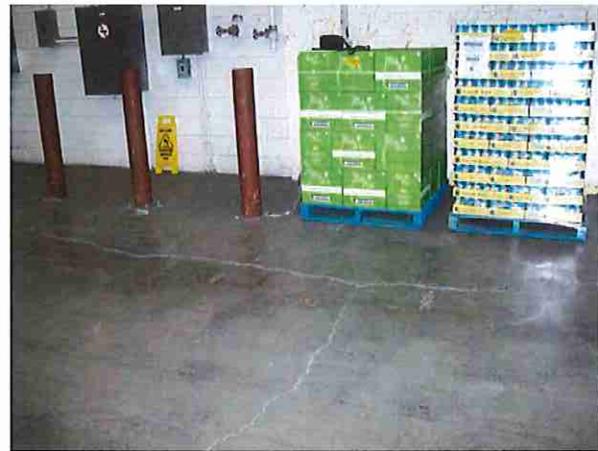
Figure 7. Intersecting floor cracks indicative of upward heave of the floor slab in a warehouse building in the City of Ottawa.

To illustrate the similarities of pyrite-induced building damage between Ireland and Canada, we can consider the case of a two-storey warehouse building in the City of Ottawa. The building was constructed in the 1960s and damage in the form of floor cracking and unevenness was first noted in the 1980s. There was a relatively high water table at the site so a sump and pump had been installed some 3.6 m below the floor slab. In addition, there was an elevator shaft that extended approximately 2.0 m below the floor slab. Damage was first noted in the form of cracking in the floor slab in the area of the building near the sump (Figure 7).

Over the intervening years, the floor heave continued to progress and was estimated to be approaching 100mm in total heave displacement. Some temporary repairs were undertaken but eventually more extensive rehabilitation was deemed necessary as the operations of the fork lift trucks were being affected.

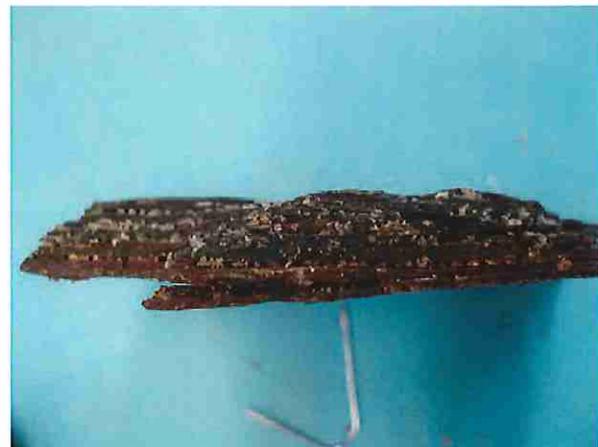
Figure 8. Close-up view of the brown Billings shale (approx. 150 mm across) with clusters of gypsum crystals on lamination surfaces.

An investigation confirmed that only a thin layer (<100mm) of compacted aggregate fill separated the underside of the floor slab from the underlying bedrock surface. The lowering of the local water table in the vicinity of the sump had allowed the pyrite in the upper portions of the shale bedrock to oxidize and for gypsum to develop between laminations (Figure 8). It could be clearly seen from visual examination that the laminations within the shale were being prised apart by the growth of gypsum.

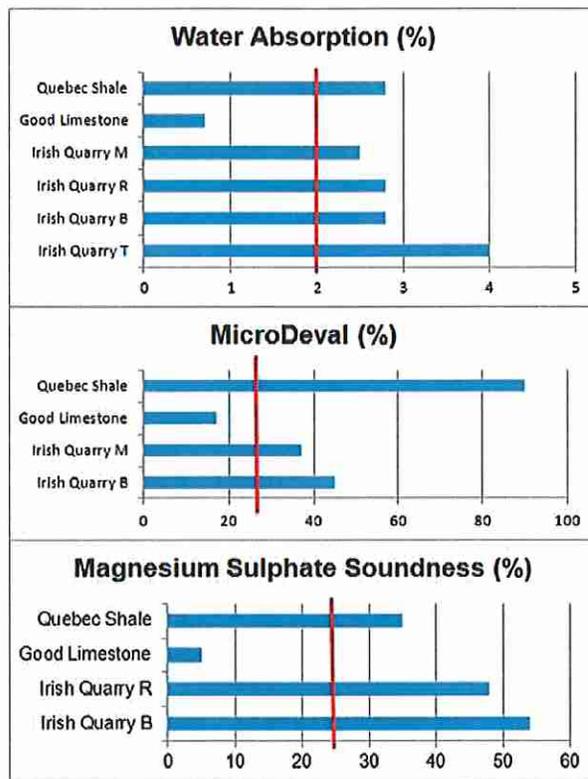
Figure 9. Typical results for Water Absorption, Micro-Deval and Magnesium Sulphate Soundness for problematic shales and mudstones from Ireland and Québec.

The low quality of the aggregates prone to pyrite-induced heave can be confirmed from conventional aggregate suitability testing. The most indicative tests are coarse aggregate absorption, Micro-Deval and Magnesium Sulphate Soundness. Results for these tests from typical Irish and Québec problematic mudstones and shales are shown in Figure 9. The red line on the charts indicates typical industry upper limits of acceptability for good quality construction aggregates. Test results for good quality crushed limestone aggregate are shown for comparison.

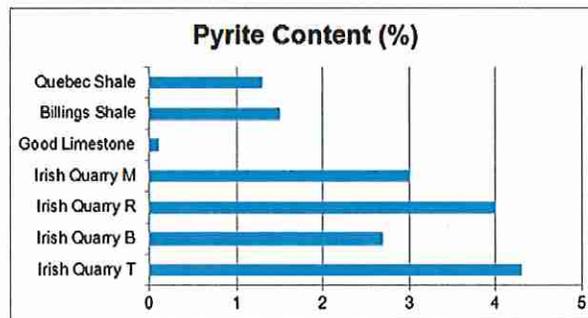
Figure 10. Comparison of estimated pyrite contents in problematic mudstones and shales.

It is not possible to establish a pyrite threshold level above which heave problems can be anticipated. This is because there are too many other variables related to the physical characteristics of the compacted hardcore as well as to the environmental conditions under which it is used. There have been cases where equivalent pyrite contents as low as 0.5% by mass have caused structural damage. This would be equivalent to 0.3 % total sulphur, which is well below the maximum concentration allowed in unbound aggregates according to European Standard EN 13242 (NSAI, 2003). Hawkins and Pinches (1992), who studied this problem in the UK, suggested that if the difference between the total sulphur content and the potential sulphur in sulphate, was above 0.5% then the material may be susceptible to ground heave. The problematic aggregates in Ireland exceed this oxidisable sulphide limit and have pyrite contents by mass of greater than 1% and more typically greater than 2% as shown in Figure 10.

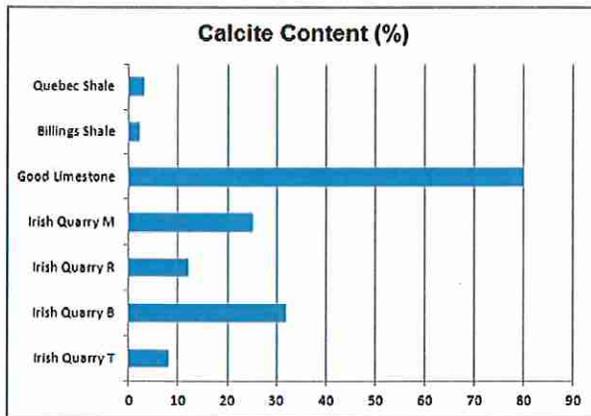
Figure 11. Comparison of calcite contents in problematic mudstones and shales.

The growth of expansive gypsum requires the availability of calcite. Most of the Irish calcareous mudstones/siltstones have calcite contents in the range of 15 to 30%. However, as little as 1% calcite is sufficient to feed the reactions. Many problematic shales have calcite contents of less than 5% (Figure 11).

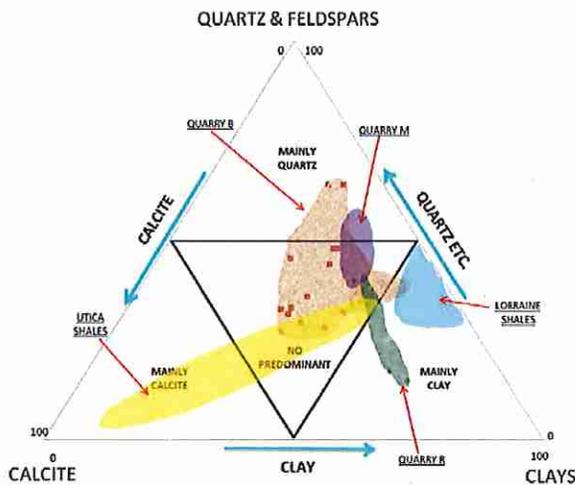
Figure 12. Comparison between Utica and Lorraine shales and Irish mudstones that cause pyrite-induced heave. Quarries B, M and R are Irish quarries.

Clay content is also an important component, as demonstrated by the basis of the Québec Swelling Index Test. A simplified tri-linear plot can be used to compare the relative proportions, of clay, calcite and other minerals in these aggregates. From Figure 12 it can be

seen that the mudstone aggregates from three problematic quarries in Ireland and those from the Québec Lorraine shales all have calcite contents less than about 40% and generally high clay contents. The Québec Utica shales are much more variable and those with higher calcite contents and low clay contents being inert and suitable for use.

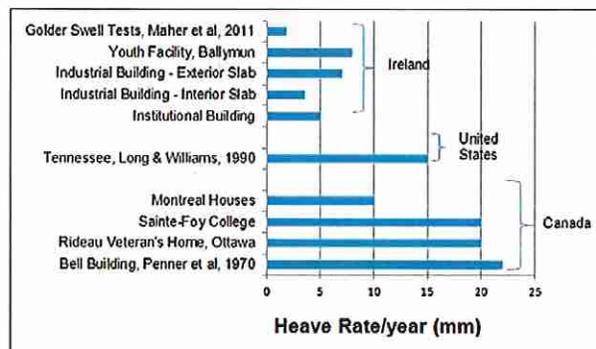
Figure 13. Recorded heave rates in buildings due to pyrite-induced heave.

Despite these variables, some orders of magnitude for rates of heave can be established from a review of monitoring in buildings that has been reported in the literature and from the results of forensic engineering investigations. Some recorded heave data is plotted in Figure 13. For North America the reported heave ranges are from 10 to 22 mm per year.

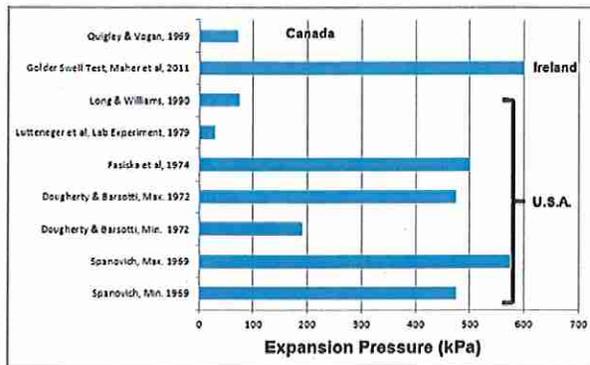
Figure 14. Comparison of estimated pyrite heave pressures from a literature review.

Figure 14 illustrates various estimates of pressures generated from pyrite expansion. It can be seen that the back analysed value from the Golder Laboratory Swell

Test (Maher et al, 2011) of 600kPa is in line with estimates made by Spanovich in 1969 (Spanovich, 1969).
