REPORT OF MEETING

SUBJECT: Lyman Viaduct – Culvert Rehabilitation Project
Town of Colchester

DATE: May 1, 2008

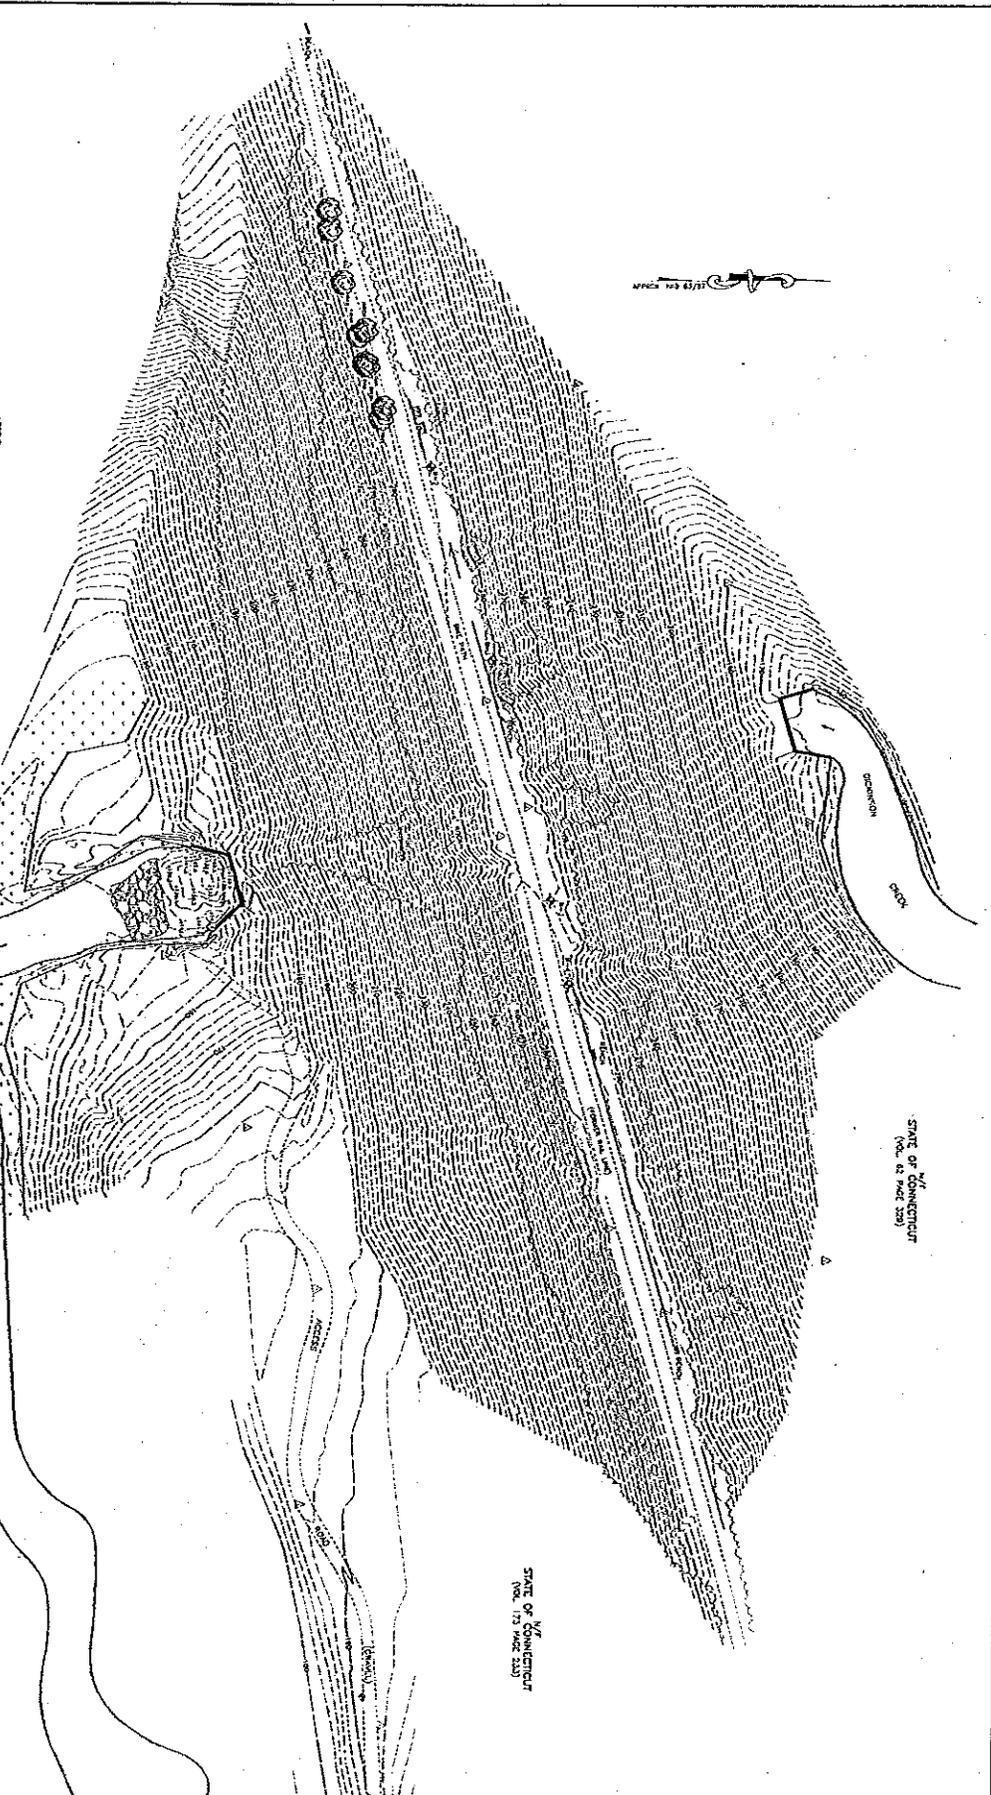
2. The outlet headwall and adjacent wingwalls are in critical condition. The southeast wingwall has already started to move, which constitutes a failed condition. The amount of undermining on all these walls combined with the movement of the southeast wingwall leads us to conclude that the structure could fail at any time. This area requires immediate rehabilitation. We would classify this condition as an emergency situation. If any of these walls were to fall into the river, the stability of the entire slope would be in question. Our previous analysis of the slope showed that the current factor of safety of the embankment is very close to 1.0. It is possible that failure of one of these walls could result in a slope failure (landslide) and potential failure of the Colchester/East Hampton Sewer Line.
